*Rehabilitation of Canadian National Railway  
Track Servicing Oil Sands in Northern Alberta*  
**The Athabasca Northern Railway**

Tom Bourgonje – CN, Regional Chief Engineer

Scott A. Diercks – Loram, Product Development Manager

2011

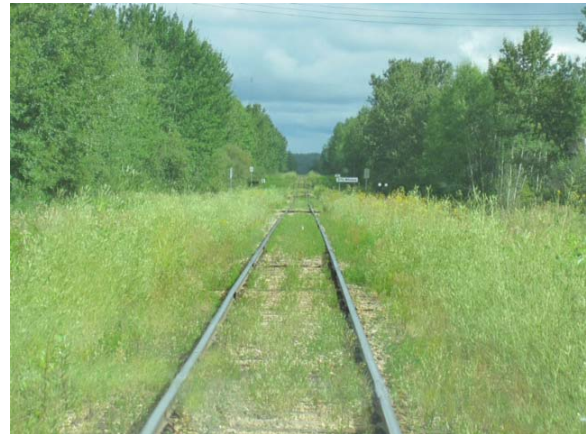
(Fig 2 - CN - ANY Inspection, 2008)

After CN took ownership of the ANY, an assessment of the track structure was conducted to determine the immediate needs to resurrect the subdivision. One determination utilized a Geometry (Geo) Test Car to analyze specific problems associated to failing track structure from Boyle to Fort McMurray. After the Geo Test Car analysis was completed, the track was deemed impassible and the test car was detained until repairs were made. Resources were immediately deployed to make all required emergency repairs to bring the track to a safe condition. Two weeks later the test car was allowed to

make the return trip to Boyle. Fig 2 is a picture taken during the inspection trip with the GEO Test Car in 2008.

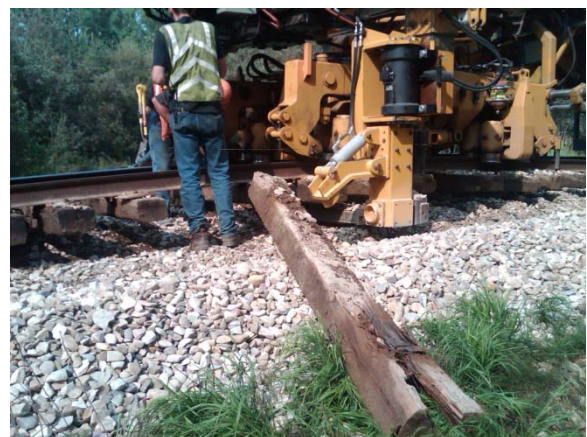
(Fig 5 - Tie failure discovered while lifting on ANY)

To prepare for a substantial increase in traffic, ties in a line carrying previously light traffic that are judged to be marginal should be replaced. Ties that look sufficient under a visual inspection can fail under the increased traffic and even under the stresses induced by raising and surfacing the track on new ballast. The wood cell deterioration is there all along; however, the light traffic volume is insufficient to cause the tie to fail. Therefore, when a significant increase in traffic occurred on the ANY Subdivision, tie failure and the breakdown of the track structure was experienced. A typical tie failure is indicated below in Fig 5.

CN management determined that a significant tie program was warranted to begin the project to ensure the track foundation could immediately handle the current needs, and preparation for potential future traffic demands. Fig 6 represents a post inspection of the extensive tie program that was completed on the ANY.

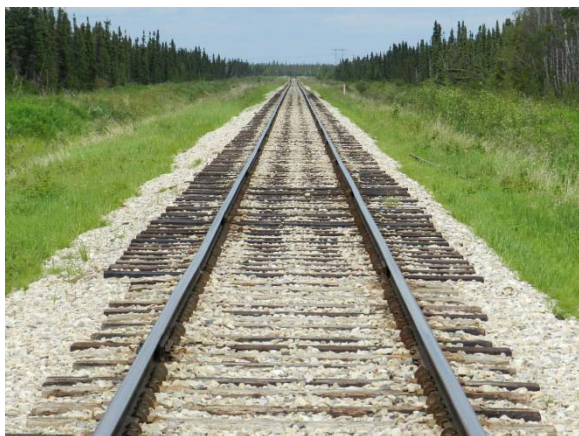
(Fig 7 - Ten foot ties in muskeg soil area)

Additional efforts were required in areas with a natural soil that consist of Muskeg. Ten foot ties, additional bank widening, and added depth of ballast was implemented to provide additional load bearing support throughout the foundation of the track. A representation of the ten foot ties installed in a muskeg region can be seen in fig 7.

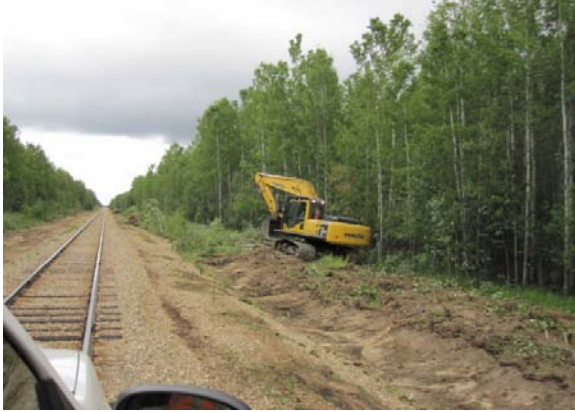
(Fig 8 - Drainage work on the ANY, 2009)

Due to the poor qualities of the existing natural soils on the ANY, drainage remediation was a must. Bank widening with dozers and excavators, utilization of the Loram Badger Ditcher and operation of a Loram Shoulder Cleaner was used throughout the line to enhance the drainage and improve the track structure. Fig 8 is an example of some of the drainage work completed during the rehabilitation project.

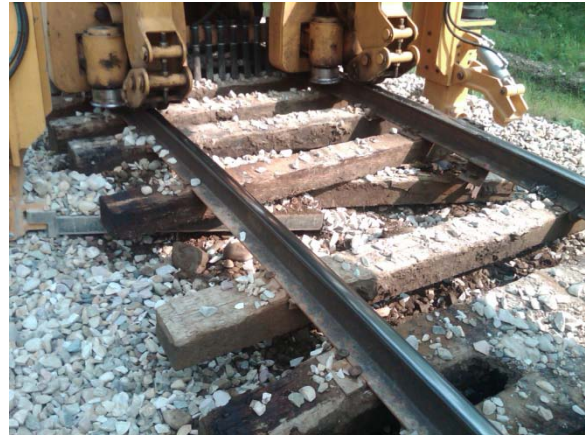
(Fig 9 - Dropped Tie on ANY Subdivision, 2010)

One of the main areas of risk identified during the planning process involved poor tie conditions encountered. It was decided that additional tie spiking efforts were required to ensure ties remained attached to the base of the rail during the lifting process. Due to the design of the machine and the lifting process, production would be halted on each occasion a dropped tie was encountered. Fig 9 exhibits issues that were encountered when lifting on the ANY Rehabilitation Project.

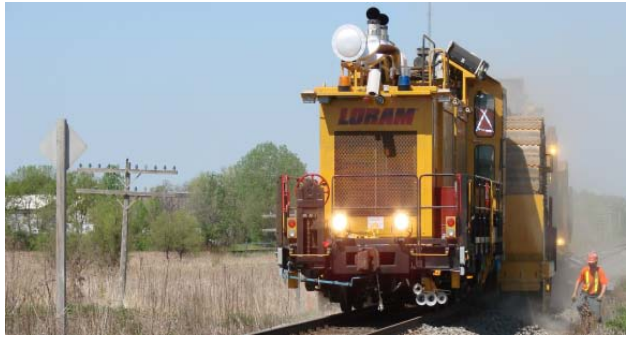
(Fig 10 - Loram Shoulder Cleaner)

Periodic cycles should be maintained with the Shoulder Cleaner to reduce the progression of fines from filling the ballast voids thus keeping the track drainage at an optimal level. Fig 10 is a picture of a Ballast Cleaner working on the ANY Subdivision.

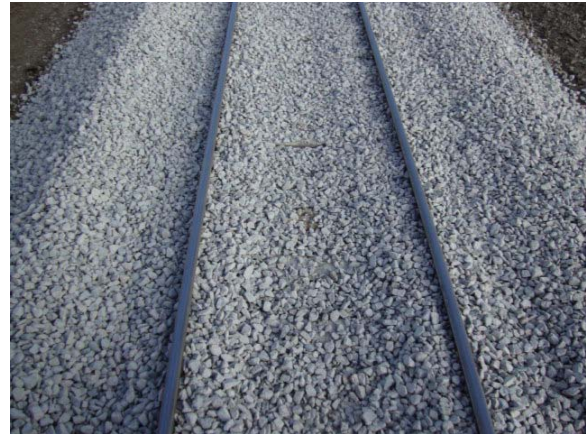
(Fig 11 - Pre Dump on the ANY, 2010)

The next step in the process was pre-dumping of ballast, which is illustrated in Fig 11. This is done to speed up the track lifting process and ensure adequate ballast was available during the project. Pre-dumping of 15 cars per mile in advance was required to allow for a 5 to 8 inch lift. The ballast was dumped on the shoulder of the track to avoid applying additional weight on top of the ties, thereby reducing the amount of dropped ties through the process of lifting. Due to logistical challenges and distance to the nearest source of usable ballast, pre-dumping ballast generally occurred months to weeks in advance of lifting.

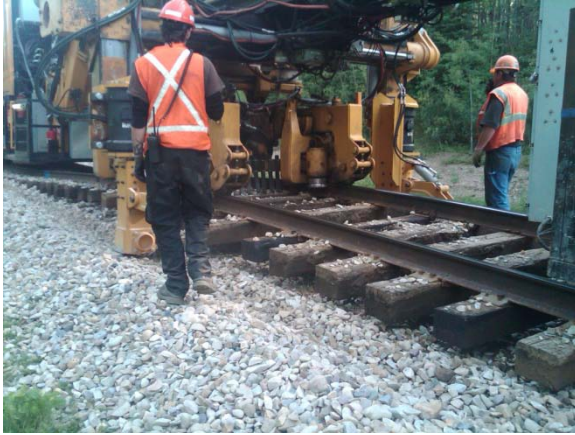
(Fig 12 - First day lifting on the ANY, 2010)

The Loram Track Lifter is a self propelled machine that can lift track up to 12 inches in one pass. The lifter is also equipped with a crib leveling bar that helps break up muddy cribs and provides a smooth level surface after the lift. Productivity of the lifter can vary depending on track conditions. During ideal conditions, it can lift track at speeds up to 4 MPH. The ANY Subdivision is predominantly jointed with 100 lbs. head free rail. Under these conditions, the track lifter worked between 1 to 2 mph. An example of the Track Lifter in operation is seen in Fig 12.

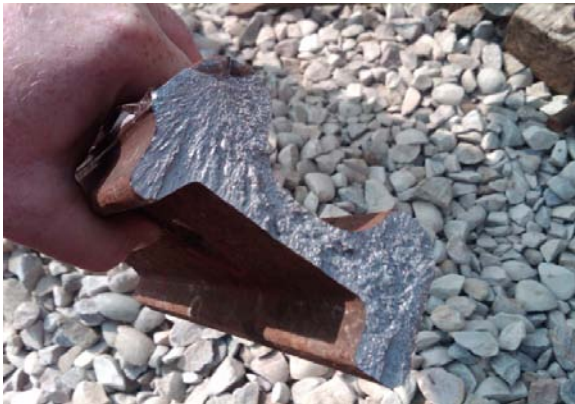
(Fig 13 - Defective joint bar on ANY, 2010)

One of the main issues encountered while lifting was the abundance of joint bars that broke. Upon a visual inspection of the broken joint bars it was easily identifiable that internal defects were present. A typical angle bar failure is represented below in fig 13.

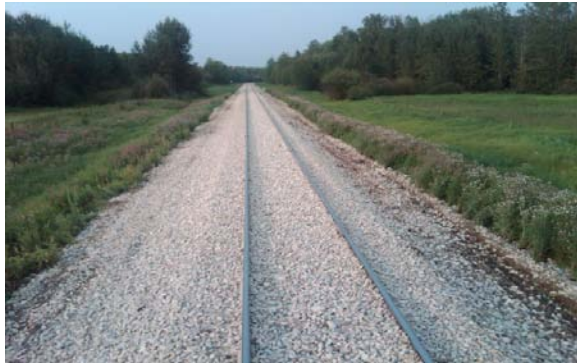
(Fig 14 - Post lift results ANY, 2010)

With proper inspections and planning, extensive work was performed on the ANY to correct many of the subdivisions

problems. Fig 14 is a representation of the restored drainage and renewal of the supporting track structure that has once again allowed this subdivision to operate in a self sustaining viable manner.
