U.S. Department
of Transportation
**Federal Railroad
Administration**

RR 11-10 | May 2011

HEAVY AXLE LOAD REVENUE SERVICE MUD-FOULED BALLAST INVESTIGATION

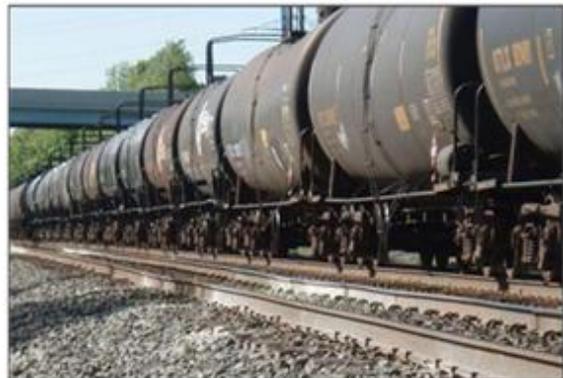
Transportation Technology Center, Inc., investigated the track substructure at three Norfolk Southern mainline sites to determine the root causes of localized mud-fouled ballast deterioration and associated track roughness, as Figure 1 shows.

The inspections were carried out by digging cross trenches in the tie cribs to a depth of 3–4 feet below the ties. The trenches revealed that water trapped in the fouled ballast layer was the main cause of the geometry deterioration at all sites. Although well-defined ditches were located next to and below the elevation of the ballast layer, the very low permeability of the fouled ballast shoulder and clay subgrade effectively blocked lateral drainage from the ballast section to the ditch. As a result, the top ballast layer was fouled with mud slurry that, in some cases, was being pumped up around the sides and ends of the ties.

Figure 1. Muddy Ballast Site with Degraded Track Geometry

Maintenance activities such as cribbing to remove fouled ballast between ties, surfacing, and ballast undercutting/cleaning to depths of 12 inches (in) or less are commonly used to deal with muddy ballast conditions. However, these methods do not necessarily restore adequate permeability of the ballast layer. Installing cross drains or ballast renewals that are deeper than 12 in below the ties may be required to restore the lateral drainage path.

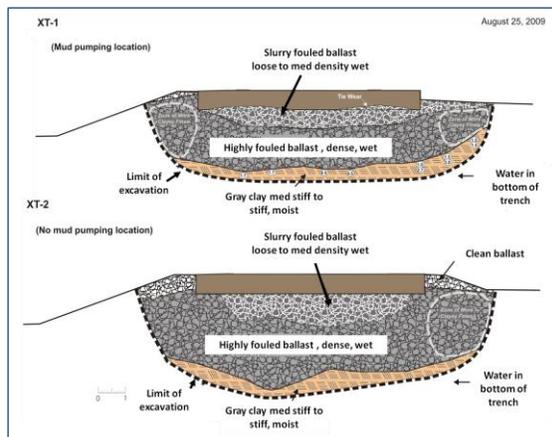
the surface and labeled XT-2 and XT-3. The substructure layer conditions at all three trenches were similar, including the following:

- A top granular layer consisting of loose to medium-dense aggregate that was wet and fouled primarily with mud slurry.
- A second granular layer, denser than the top layer, very wet and fouled, but without the mud slurry.
- Subgrade of moist plastic clay, gray in appearance and moderately stiff at the surface, becoming increasingly stiff a few inches below the subgrade surface.

The only difference in the appearance of the three trenches was that the mud slurry in the top layer had pumped through the shoulder ballast at XT-1 to form a mud spot (Figure 2).

Figure 2. Similarity of XT-1 and XT-2 Cross Sections

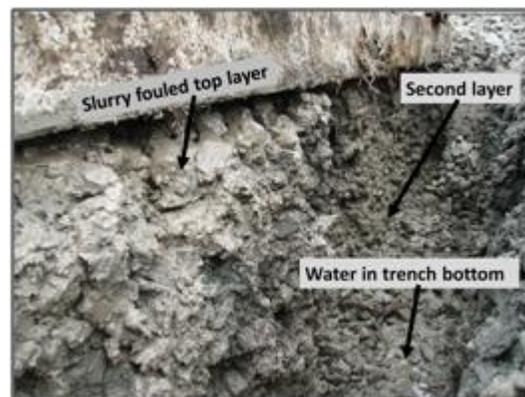
Two cross trenches were dug at the RD 83.0 site: one at a mud spot labeled XT-5 and the other at a non-mud spot labeled XT-4. The conditions at these trenches were somewhat similar to PC 59.1, as Figure 3 shows, and are described

- The mud spot had a top layer less than 12 inches deep that was wet and fouled with mud slurry material.
- It had a second layer, denser than the top layer, also wet and fouled, but without the slurry. Water also collected at the bottom of the trench as at PC 59.1.
- The hardpan layer, consisting of cemented limestone and slag, was located between the second granular layer and the subgrade. The subgrade that was visible at the edge of the hardpan was moist clay.

Figure 3. Ballast Condition at XT-5 Cross Trench

Plans are in place to install a mud spot remediation test at the site near Ravenna, OH. The approach will be to install an impermeable layer between the top and bottom ballast layers to facilitate drainage and isolate the fouled bottom ballast from the clean top ballast.

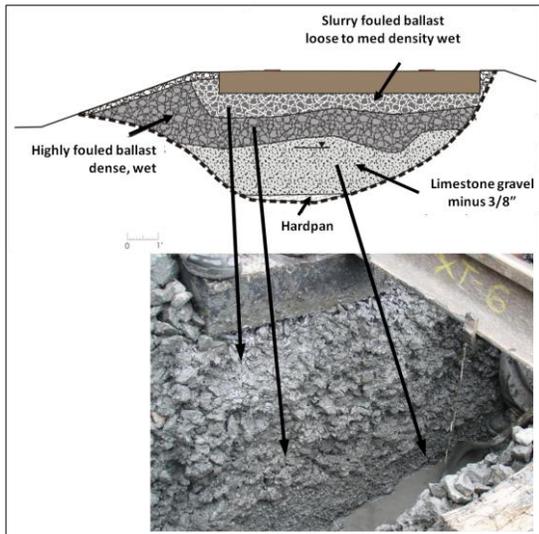
Two cross trenches were dug at the CNO&TP 75.5 site labeled XT-6 and XT-7. As with the other sites, the granular layers were very wet with water collecting in the bottom of the trench, along with slurry-fouled top layer and a denser, highly fouled second layer. However, there was a third layer of medium-dense granular limestone gravel subballast sitting on a hardpan layer (Figure 4). This site was slightly different from the other two in that there was more water present, and the slurry tended to pump through the ballast

shoulder near the toe, rather than pumping up around the ties.

Figure 4. Ballast Layers at the CNO&TP 75.5 Site
