# ***Studying the Effects of the Loram HP Shoulder Ballast Cleaner on Brazilian Heavy-Haul Railways***

**Abstract:** This study focuses on the imperativeness of well-maintained railway ballast and its effects on the life of rolling stock, wheels, rail, ties, and other track structure components. If ballast is improperly maintained, several problems can occur on the track and/or with the rolling stock, including serious derailment accidents. This essay presents the results of utilizing a Loram High Performance Shoulder Ballast Cleaner (SBC) to clean railway ballast. Several measurements have been taken by MRS-Logistics to determine the effects of shoulder ballast cleaning, including the rate of contamination in the ballast, the track modulus, track geometry, and track quality index. Measurements were taken both before and after shoulder ballast cleaning, as well as before and after heavy rain events. Presented through the collected data outlined in the following sections, shoulder ballast cleaning is proven to be an excellent method in the restoration of track drainage, particularly in tropical areas that experience heavy rains on an annual basis.

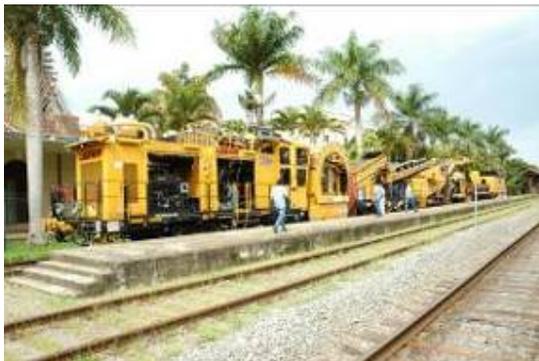
Fig. 2 Loram Shoulder Ballast Cleaner

Using the least track occupancy possible, the SBC has the capacity to clean at 2.0 miles per hour and is completely controlled by a PLC system, reducing maintenance and operational costs. Figure 2 shows a photograph of the machine in the courtyard of the company in Juiz de Fora – MG.

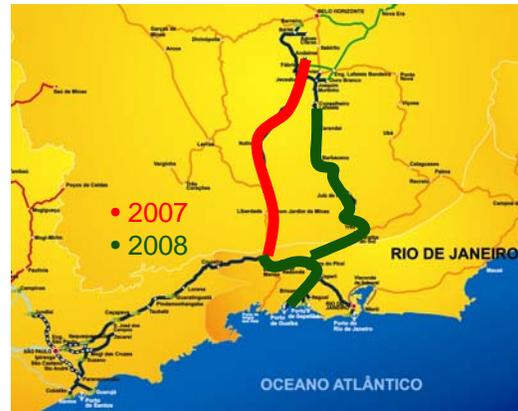
Fig. 3 SBC coverage in 2007 & 2008

Figure 3 illustrates where the machine worked on MRS Lines.

In less than two years of use, the MRS SBC has had an output of approximately 500 miles, operating on a variety of railways and throughout high density traffic. The Steel Line has been a challenge because of the high volume of traffic, and the Center Line because of its highly contaminated ballast and age.

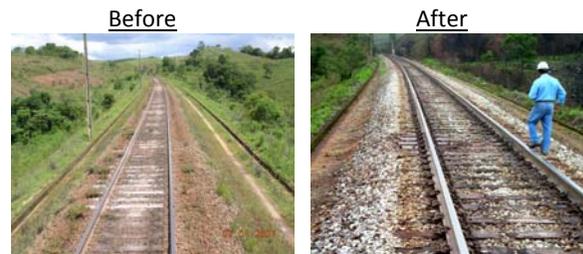
Fig. 4 (a). Steel Line - km105 + 980

After utilizing the SBC on the ballast shoulder on the Steel Line which contains a large amount of mudspots, the route has a significantly better appearance after a rainfall (see Figure 4).

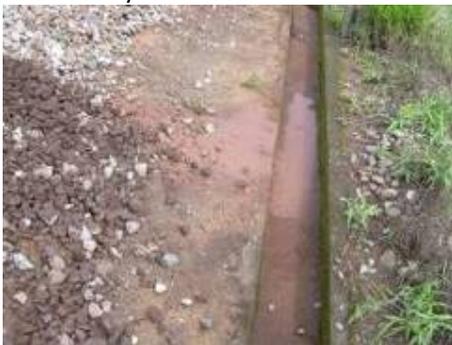
Fig. 7. Fine material carried down by rain water Bom Jardim – MG

The photo shown in Figure 7 shows how fines are carried in ballast. When the shoulder is clear, it means the fouling index is low. The fines can then be carried out by rain water.
