# **AUTOMATED SLEEPER INSPECTION USING INTERNAL IMAGING TECHNIQUES**

Jeb Belcher  
Emerging Technologies Developer  
Georgetown Rail Equipment Company  
111 Cooperative Way, Suite 100, Georgetown, Texas 78626 USA  
belcher@georgetownrail.com  
(512) 240-5153

## **ABSTRACT**

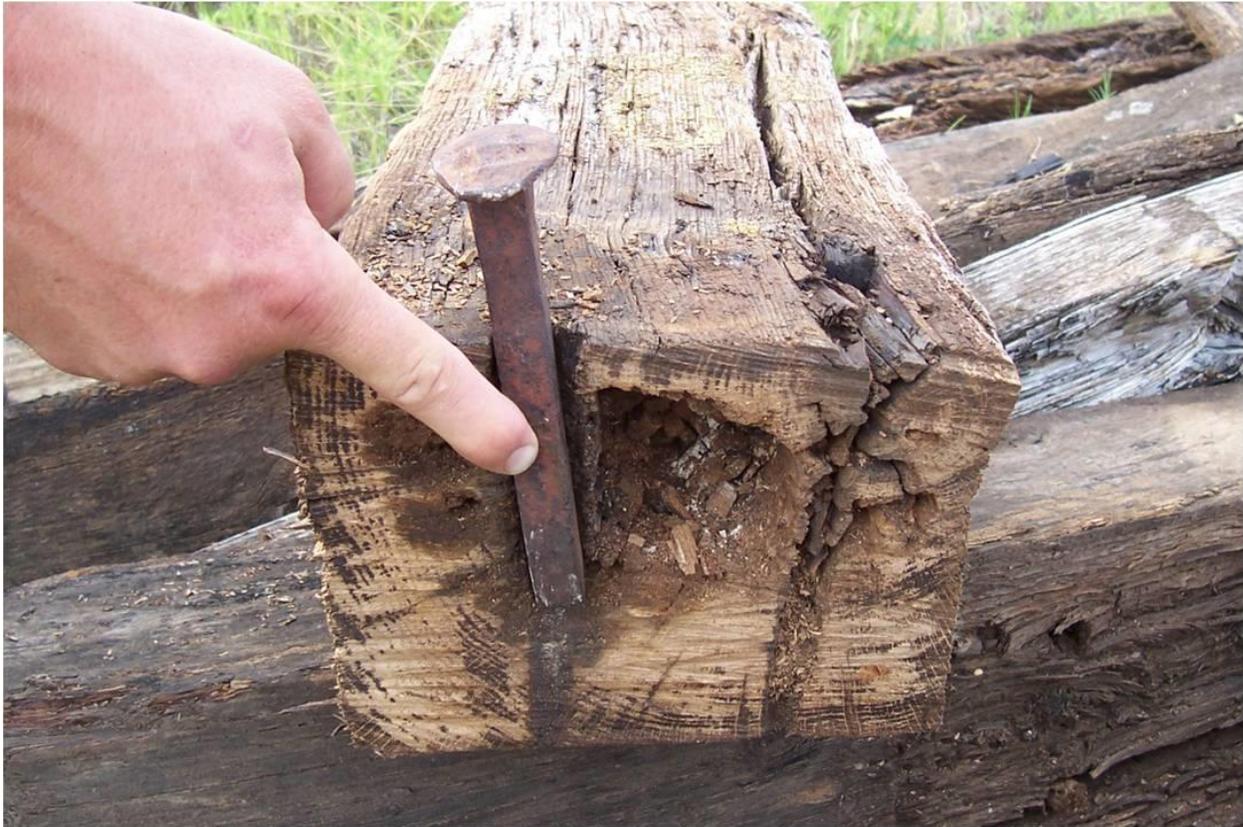
Figure 2: A Subsurface Defect is shown in proximity to a spike hole

Traditional grading techniques involve human sleeper inspectors visually grading the sleeper surface and kicking the sleeper to determine if it is hollow or not. The reliability of this technique for grading purposes is questionable. Results can vary based on which part of the sleeper was struck, surface accessibility, and type of sleeper material (timber species, etc.). See **Error! Reference source not found.** for an example of a sleeper with a localized subsurface flaw.

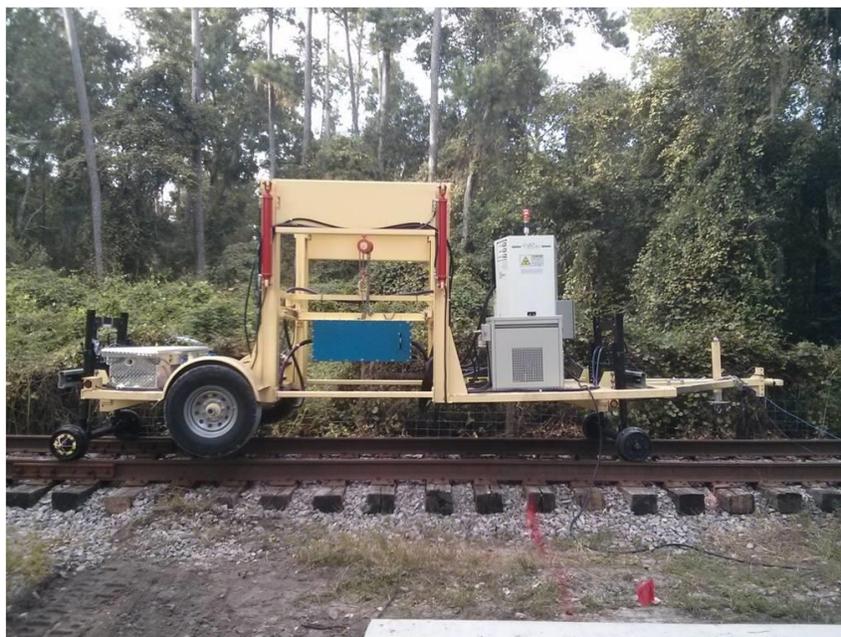
Figure 5: Research cart on the timber sleeper research track. The blue box in the center of the cart houses the Source.

Additionally, a hi-rail research cart (see **Error! Reference source not found.**) was designed and fabricated to provide the ability to test and verify various configurations of the X-ray components, and relevant system and safety design. Features of the research cart include:

- The ability to position the Source at heights ranging between 24 in (61 cm) and 84 in (213 cm) above the surface of the sleepers.
- The ability to move the Source laterally 30 in (76 cm) from the centerline of the track in either direction.
- The ability to rotate the Source laterally 30° from perpendicular to the track surface in either direction.
- The ability to tow behind an Aurora truck without interfering with Aurora's image acquisition. This allows system integration research without having to build an Aurora system on the research cart.

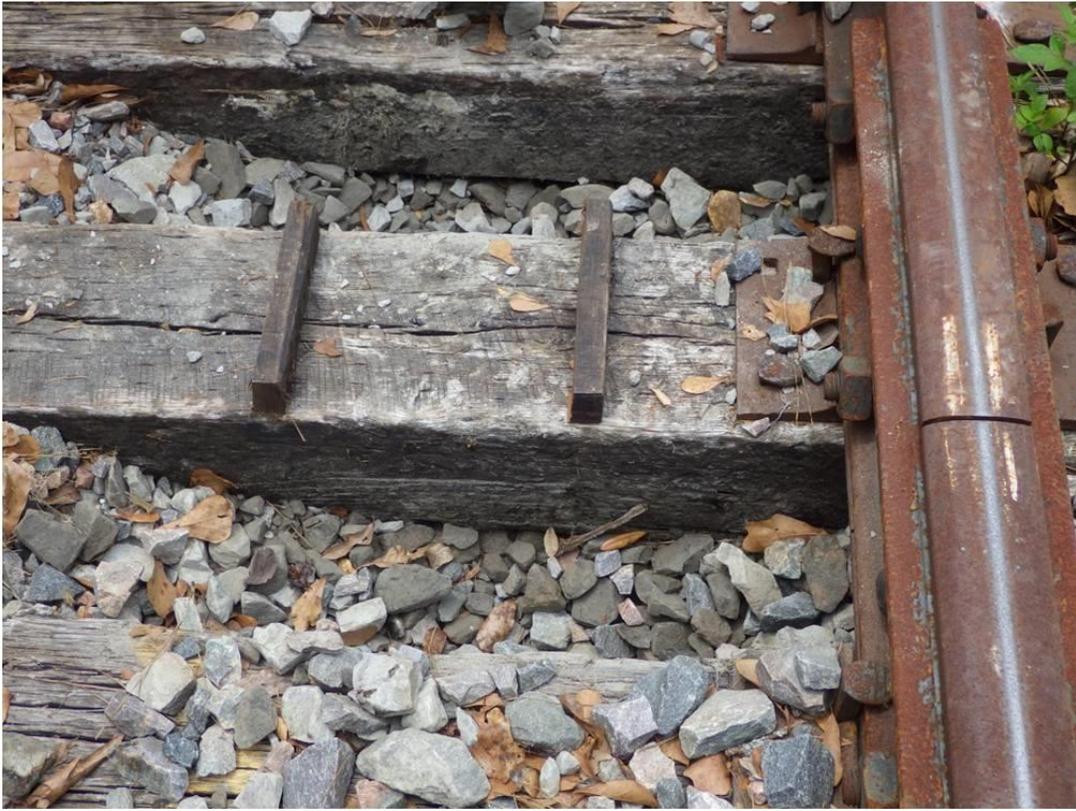
Figure 8: Sleeper surface before destructive examination. The void in the X-Ray image is between the two cross-member timber blocks.

Of particular interest was the leftmost sleeper in **Error! Reference source not found.**. The density profile ranged from 700 – 900, and showed a larger degree of variation in values across the sleeper. Also a significant void is visible near the top part of the image. However, the surface of the sleeper is in good condition (see **Error! Reference source not found.**). The crib ballast around the sleeper was removed and the 3 visible faces of the sleeper examined which showed no sign of internal defects. The voided region indicated in the X-Ray image is marked by the 2 cross-directional timber blocks. A destructive test was performed on this sleeper to verify the X-Ray results. The results are shown in **Error! Reference source not found.**.

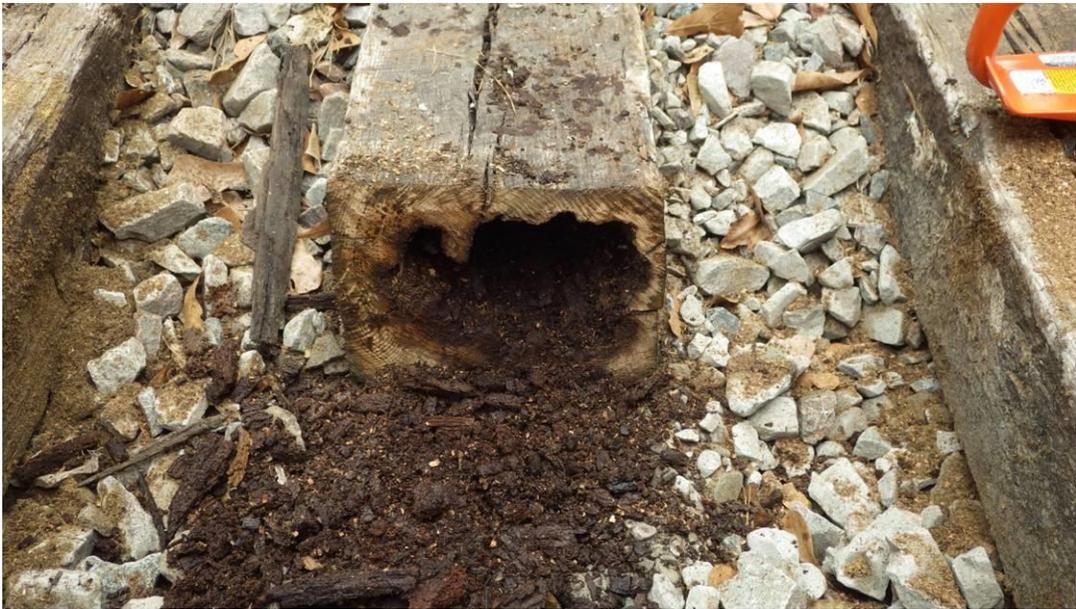
Figure 9: Sleeper surface and subsurface after destructive examination. The void is readily apparent.
