**BALLAST SHOULDER
CLEANING EVALUATION**

P-15-006

for Loram Maintenance of Way, Inc.

**Transportation Technology Center, Inc.
A subsidiary of the Association of American Railroads
Pueblo, Colorado USA
February 25, 2015**

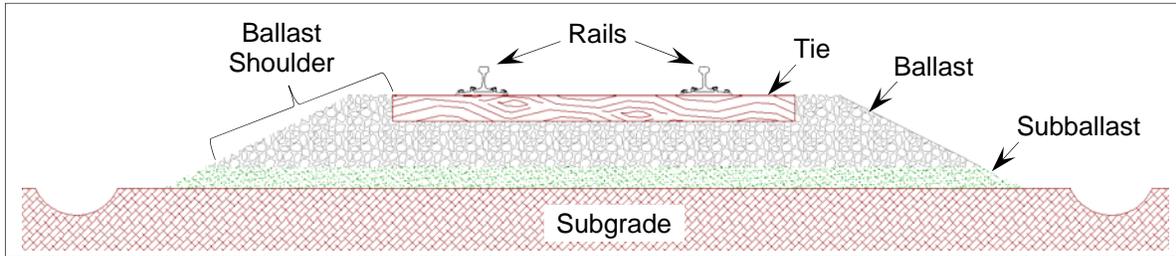
Figure 1. Typical New Ballasted Track Structure

The railroad track structure is designed to distribute the large loads from vehicle wheels to the subgrade under the track. Figure 1 details a typical new ballasted track structure.

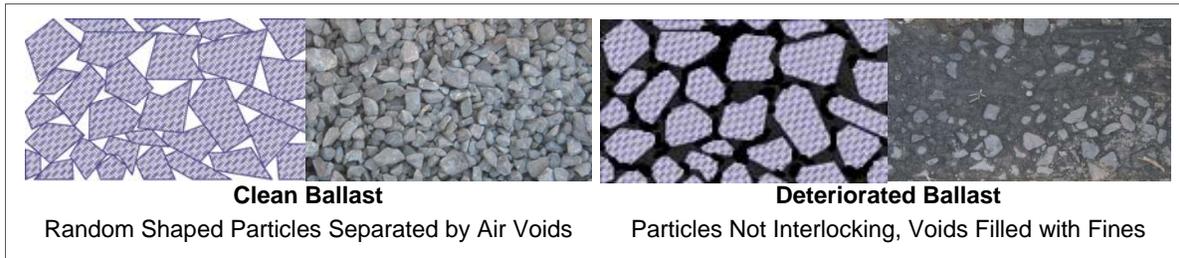
Figure 2. Comparison of Clean and Deteriorated Ballast

deteriorates, the amount of fines filling the voids increases. These fines are typically generated by degradation of the ballast particles or from the intrusion of wind-blown materials from outside the track. When the voids are filled with fines, free drainage of water is impaired and the individual ballast particles do not interlock with each other. Ballast faces may also become lubricated with the hydrated fines slurry, causing lowered internal friction of the ballast mass (see Figure 2).

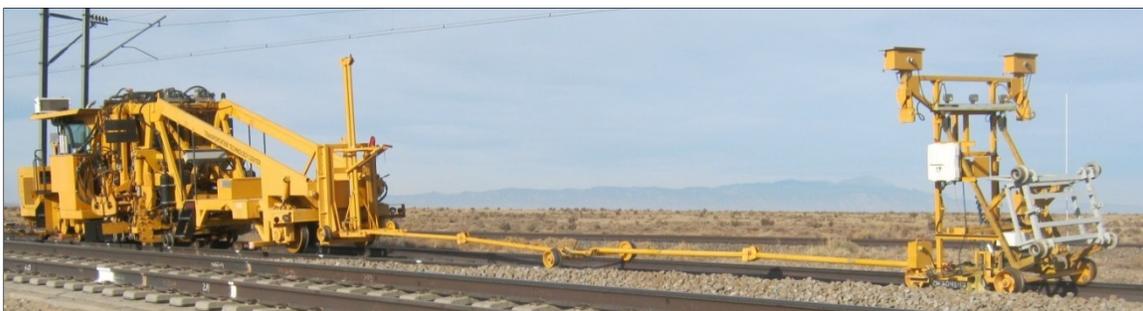
Figure 3. Track Surfacing and Alignment Machine

Track surfacing is typically performed using large machines that lift the track and packs ballast under the ties, as Figure 3 shows.

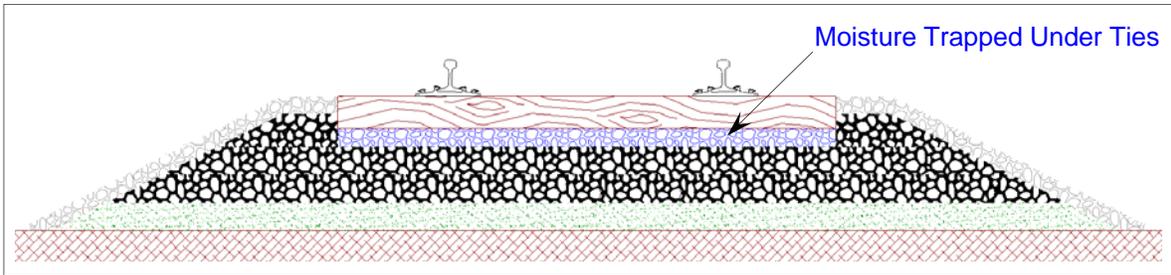
Figure 4. Track Surfacing Without Shoulder Cutting

If track surfacing is performed on track with poor draining ballast without treating the shoulders, track deterioration can be accelerated by moisture trapped under the ties, as Figure 4 shows.

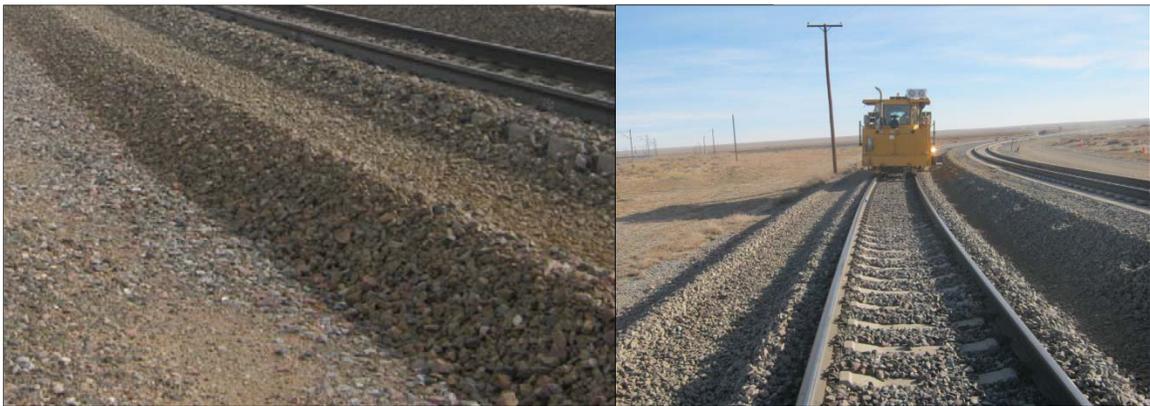
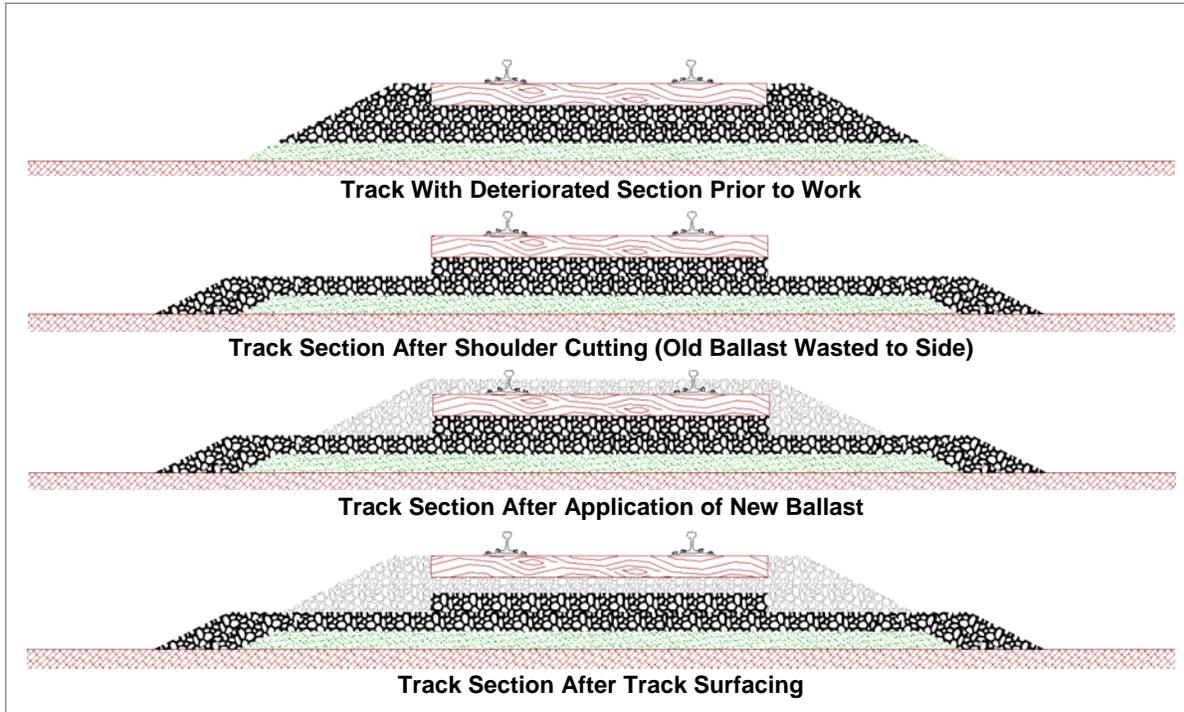
Figure 5. Shoulder Cutting to Improve Drainage

If the ballast is highly deteriorated, advance ballast shoulder cutting may be performed to improve track drainage, prior to track surfacing, as Figures 5 and 6 show. This methodology requires the replacement of large amounts of ballast and requires sufficient right of way space to waste the deteriorated ballast. The disadvantage to this strategy is that all of the shoulder ballast is wasted, requiring a significant amount of makeup ballast. For a typical ballast section, with 12 inches of ballast below the ties, and 12-inch shoulders with 2:1 slopes, this could be as much as 1,600 cubic yards of ballast per mile, where little or no makeup ballast is required for shoulder cleaning. With ballast weighing 1.35 tons per cubic yard, this equates to approximately 2,160 tons of ballast or twenty-two 100-ton ballast cars per mile.

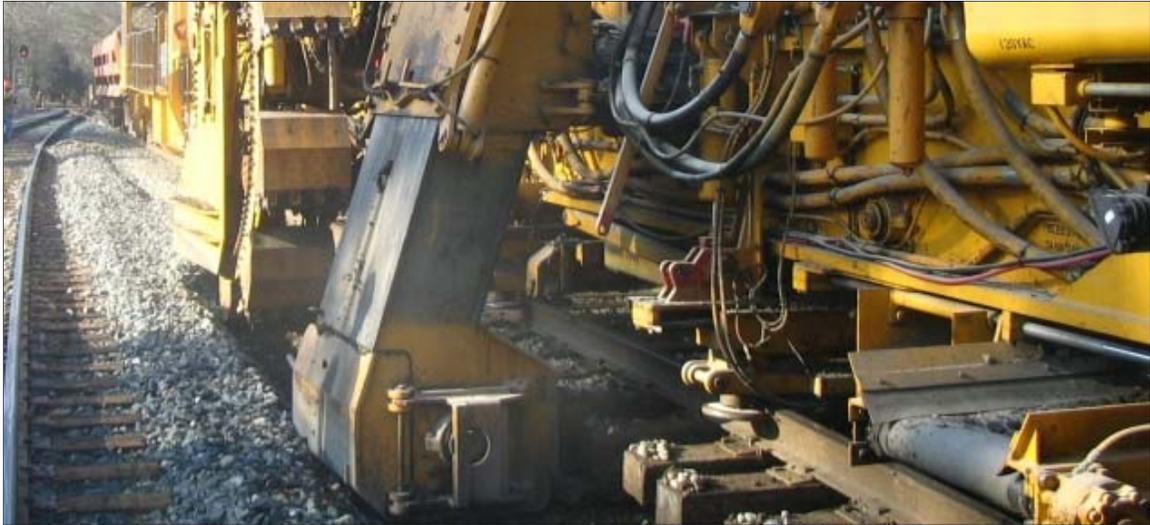
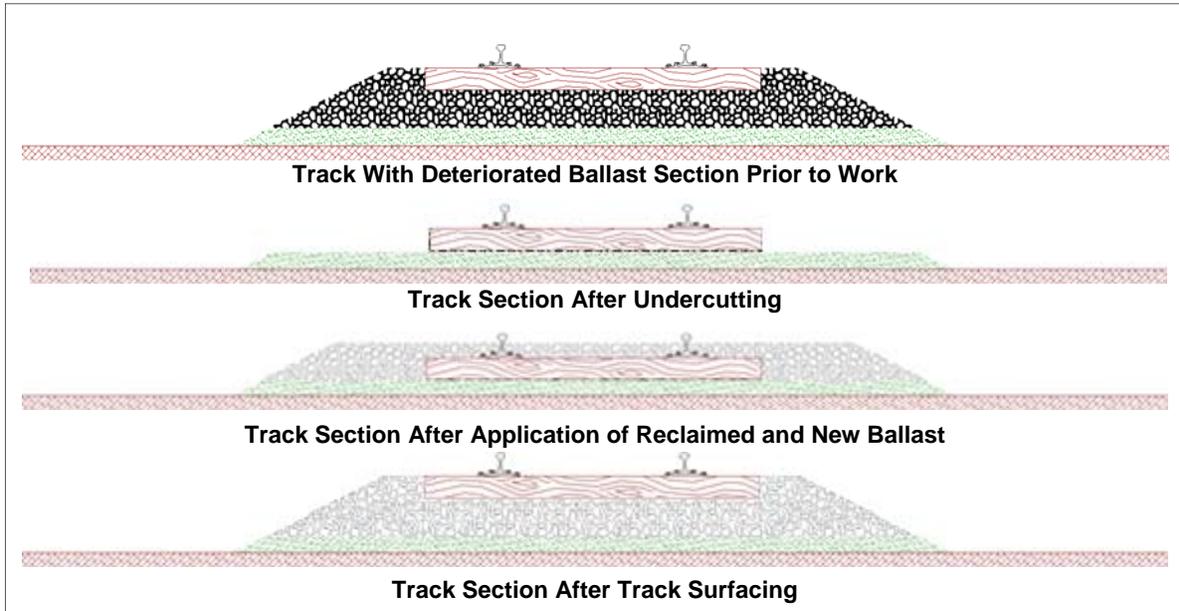
Figure 7. Track Undercutting³

Track undercutting uses a digging arm under the ties. Utilizing a combination of the undercutting arm and conveyor system, the old ballast is lifted into the machine and then screened to remove fines. The clean ballast is then returned to the track (see Figures 7 and 8). For a typical ballast section, with 12 inches of ballast below the ties and 12-inch shoulders with 2:1 slopes, and assuming a 50 percent recovery rate of the old ballast, this process may require as much as 1,892 cubic yards of ballast per mile. With ballast weighing 1.35 tons per cubic yard, this equates to approximately 2,600 tons of ballast or twenty-six 100-ton ballast cars per mile.

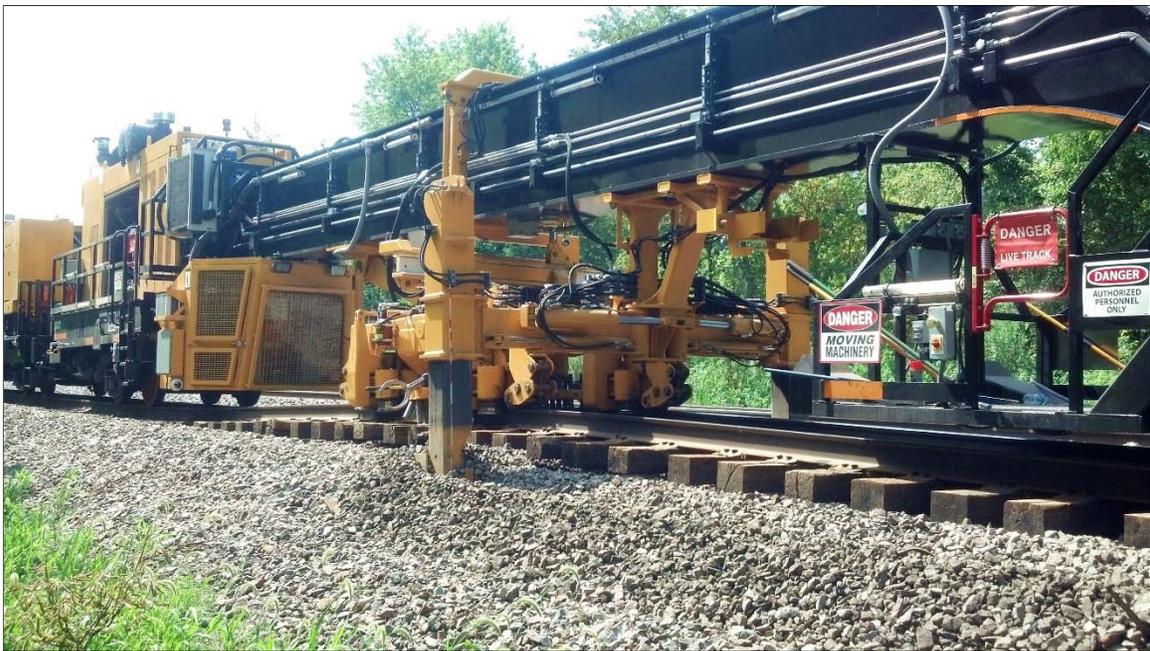
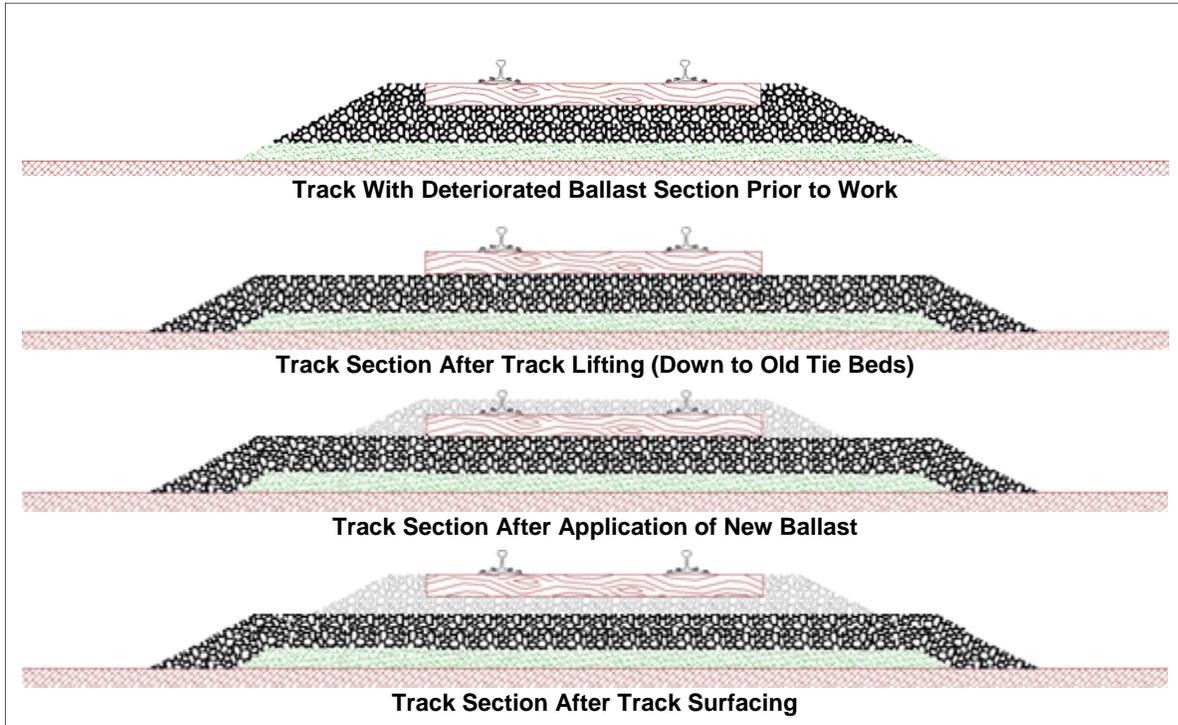
Figure 10. Loram Track Lifting Machine⁵

called a “track lifter.” This is a self-propelled machine and does not require a locomotive for operation. This process provides a higher level of productivity than track undercutting, but does require the addition of new ballast for the rehabilitated ballast section. Figure 11 provides an example of before and after the process using track lifting. For a typical ballast section, with 12 inches of ballast below the ties and 12-inch shoulders with 2:1 slopes, this could require as much as 3,784 cubic yards of ballast per mile, where little or no makeup ballast is required for shoulder cleaning. With ballast weighing 1.35 tons per cubic yard, this equates to approximately 5,100 tons of ballast or fifty-two 100-ton ballast cars per mile.

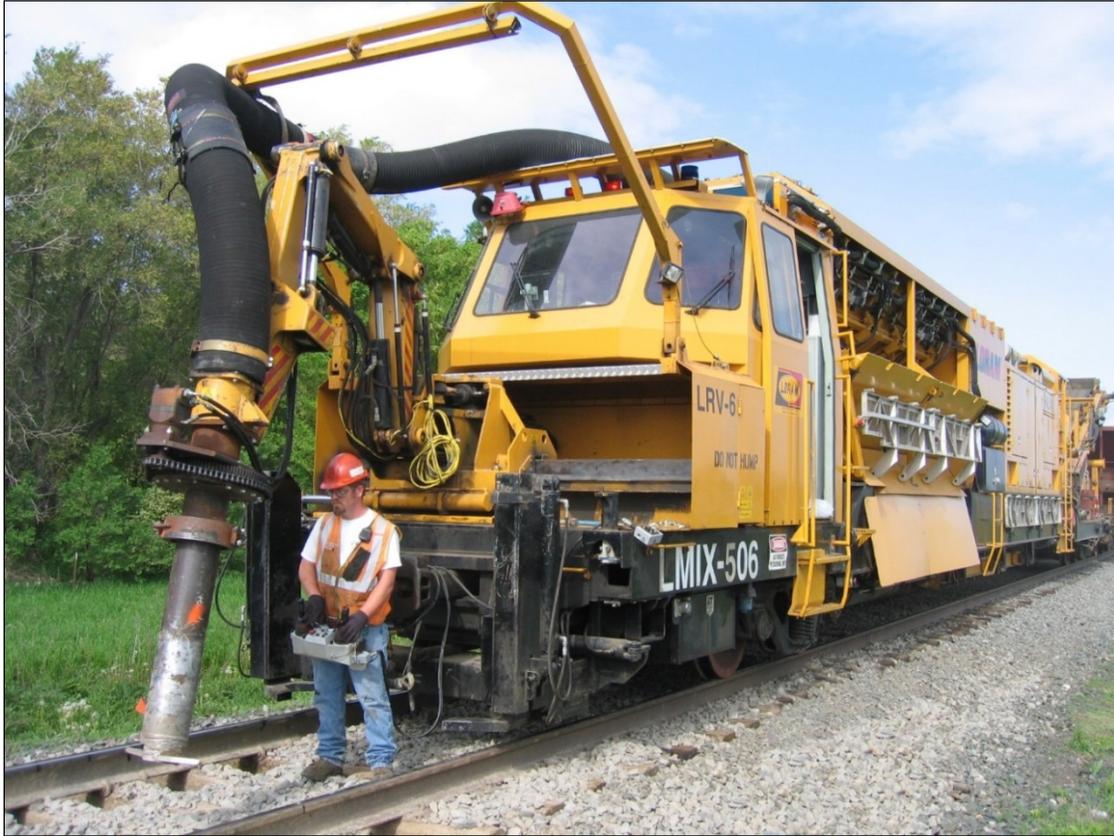
Figure 12. Loram RAILVAC™ Ballast Vacuum Machine⁶

Ballast vacuum machines are equipped with large articulated nozzles that fit between the ties and removes ballast using suction. The suction nozzle is equipped with rotating digging fingers that aid in the displacement of cemented ballast under the ties (see Figure 12). These machines use the same principal as a home vacuum cleaner, only scaled up significantly in size and capacity. The removal production of these machines is typically about 30 cubic yards of ballast per hour, which is equivalent to about 30-track feet of full ballast section per hour. While the production rates of this type of machine are much lower than other treatments, they have the benefit of being able to work in areas with limited clearances, create additional drainage paths, and can easily avoid damaging other accessories in and around the track, such as communications, train control, and traction power equipment. Additionally, set-up and clear-up times are very short, which can improve overall productivity where only short work windows are available and where spot work is required.

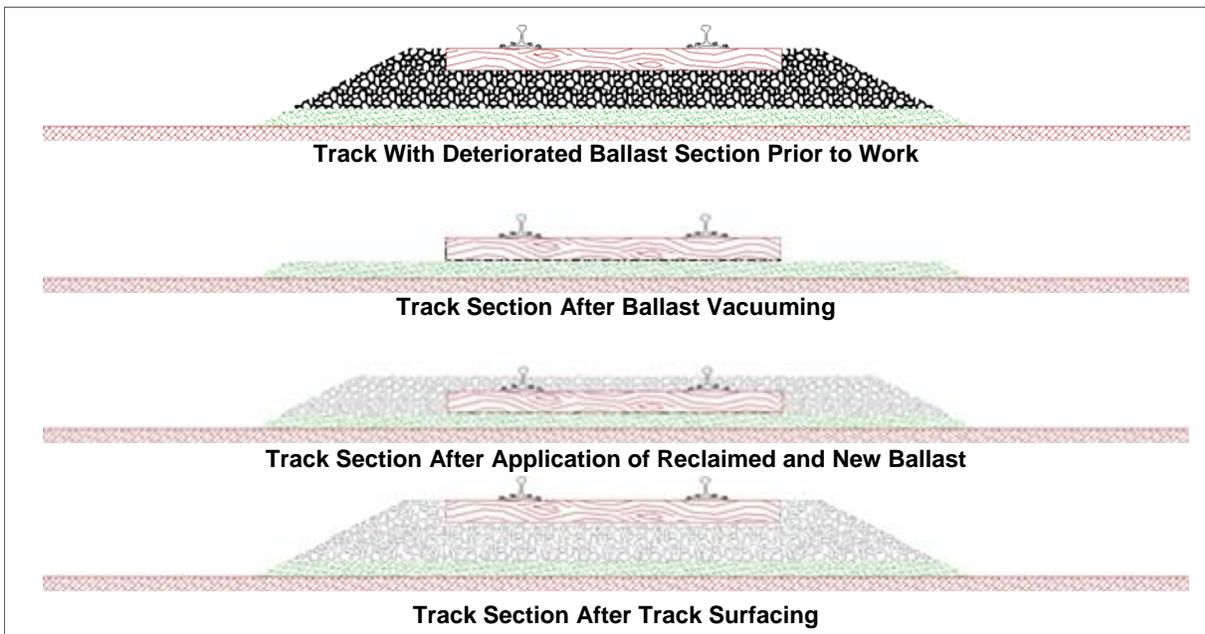
Figure 13. Ballast Vacuuming

These machines are typically designed only to remove the ballast for wasting, so the full-ballast section must be replaced, as Figure 13 shows. However, the location of the removed ballast can be carefully controlled with this process. It is possible to leave the tie supporting ballast under the ties, such that immediate track surfacing is not required. If the entire ballast section is removed, then approximately 3,784 cubic yards of ballast per mile or 5,100 tons (at 1.35 tons per cubic yard) or fifty-two 100-ton ballast cars per mile is required, less if the tie supporting ballast is not removed.

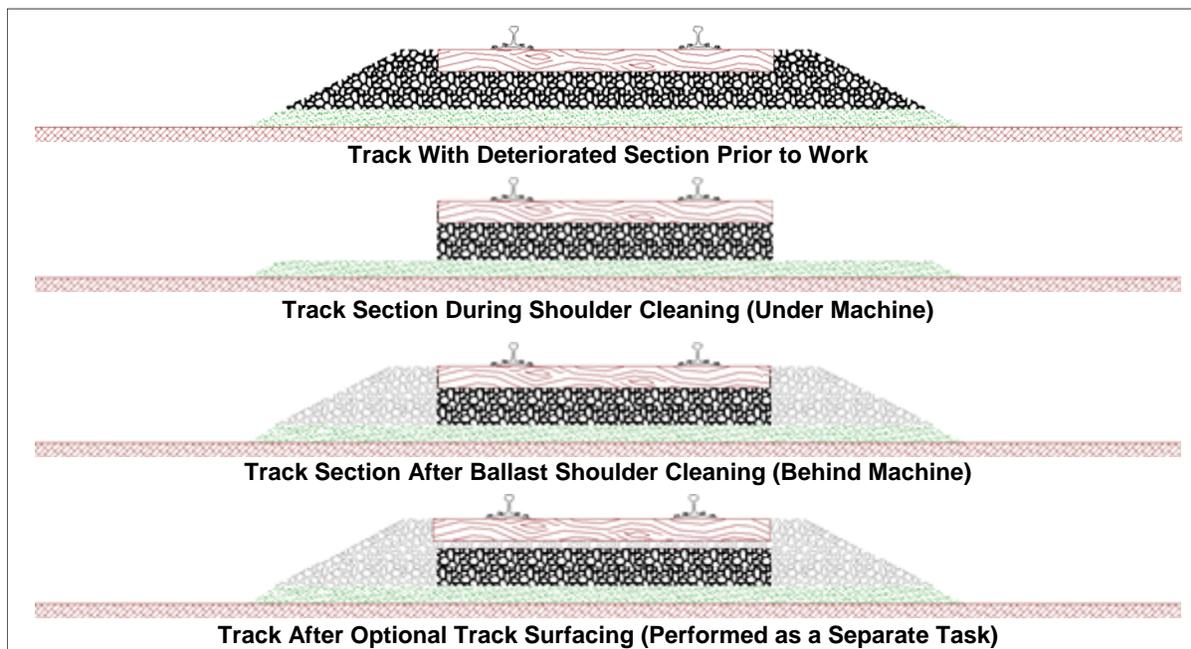
Figure 14. Ballast Shoulder Cleaning

Ballast shoulder cleaning machines have large cutting wheels that run along both ends of the ties. Without disturbing the track geometry, the ballast shoulders are completely removed. Most shoulder cleaning machines process the removed ballast, screening out the fines and returning the recovered ballast to the track. Because the shoulder ballast is not subjected to particle size reducing wear, such as tamping and train action, the cleaning process recovers nearly all of the volume, only removing the fines to re-create the voids needed for effective drainage. During the shoulder cleaning process, as the cleaned ballast is returned to the track, the ballast shoulder is regulated and the tops of the ties are broomed, completely restoring the ballast shoulders. Only a short segment of track has the tie ends exposed, under the ballast cleaning machine, during production, with the track restored as a part of the process. Unlike many other ballast cleaning or replacement processes, ballast shoulder cleaning is self-sufficient, and there is minimal disturbance to the track and little support (such as ballast trains and surfacing and alignment equipment) is needed. When working under traffic conditions, the shoulder cleaning process can be quickly stopped for clearing for trains, and typically no speed restrictions are required. Some railroads will surface and align the track following ballast shoulder cleaning to introduce clean ballast under the ties to further improve track drainage (see Figure 14). Assuming an average 3-inch track raise and a full-ballast section, the additional tamping requires approximately 850 cubic yards (1,150 or eleven 100-ton cars) of ballast per mile. Table 2 compares the ballast requirements for the various processes described.

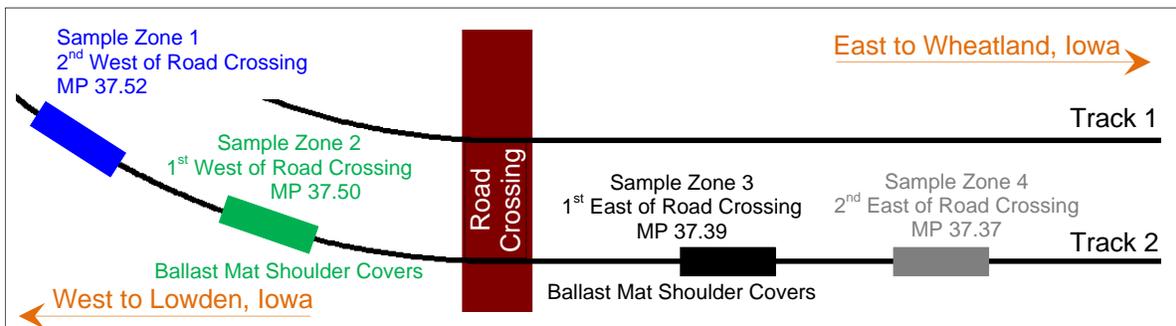
Figure 17. Test Site Layout

There were four ballast sample collection zones at the test site. Two zones were located on curved track (Zones 1 and 2), in the full body of the curve, and the other two were located on tangent track (Zones 3 and 4). The ballast shoulders were covered on one curved zone (Zone 2) and one tangent zone (Zone 3). Covers were installed to filter out any external fines (see Figures 17, 18, and 19). Each zone was approximately 100 feet long.

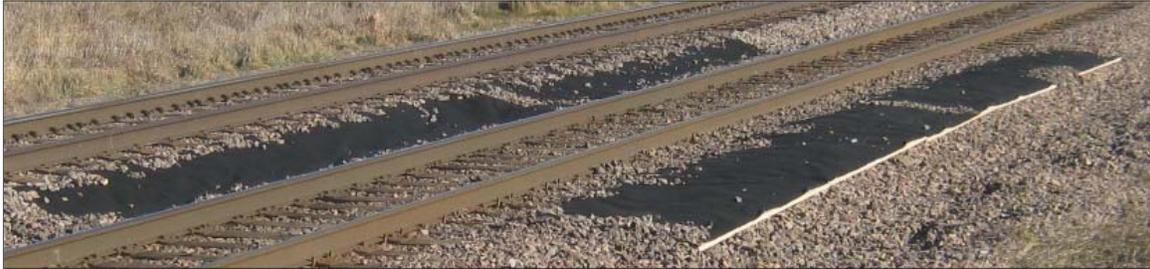
Figure 20. Ballast Mat Shoulder Covers

One each of the curved track (Sample Location 2) and tangent track (Sample Location 3) sample locations had ballast mats installed over the ballast shoulders to prevent external sources of fines (mineral fines dust or wind-blown dust) from infiltrating the ballast and to provide a comparison to the uncovered sample locations (see Figure 20). No discernable difference was seen in the results between the covered and uncovered areas indicating that the primary source of fouling material is not external.

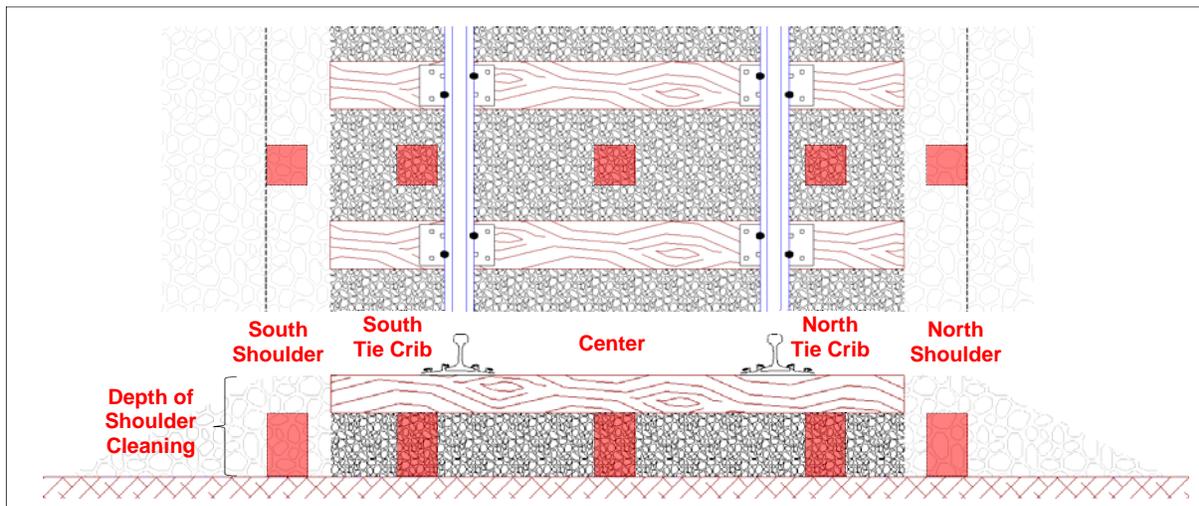
Figure 21. Ballast Sample Locations

Five samples were planned to be collected at each of the four sample locations (20 total) but varied at each collection cycle. Samples were collected, from the bottom of the tie to the depth of the ballast shoulder cleaning, approximately 12 inches below the bottom of the tie as Figure 21 shows.

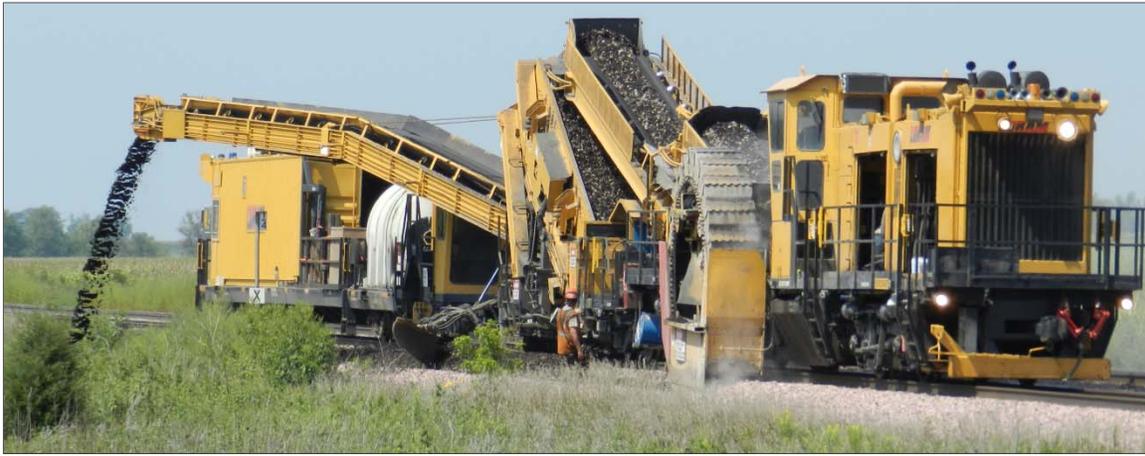
Figure 23. Loram Ballast Shoulder Cleaning Consist

Loram performed ballast shoulder cleaning throughout the test site as part of a normal shoulder cleaning operation on this subdivision (see Figures 23 through 28).

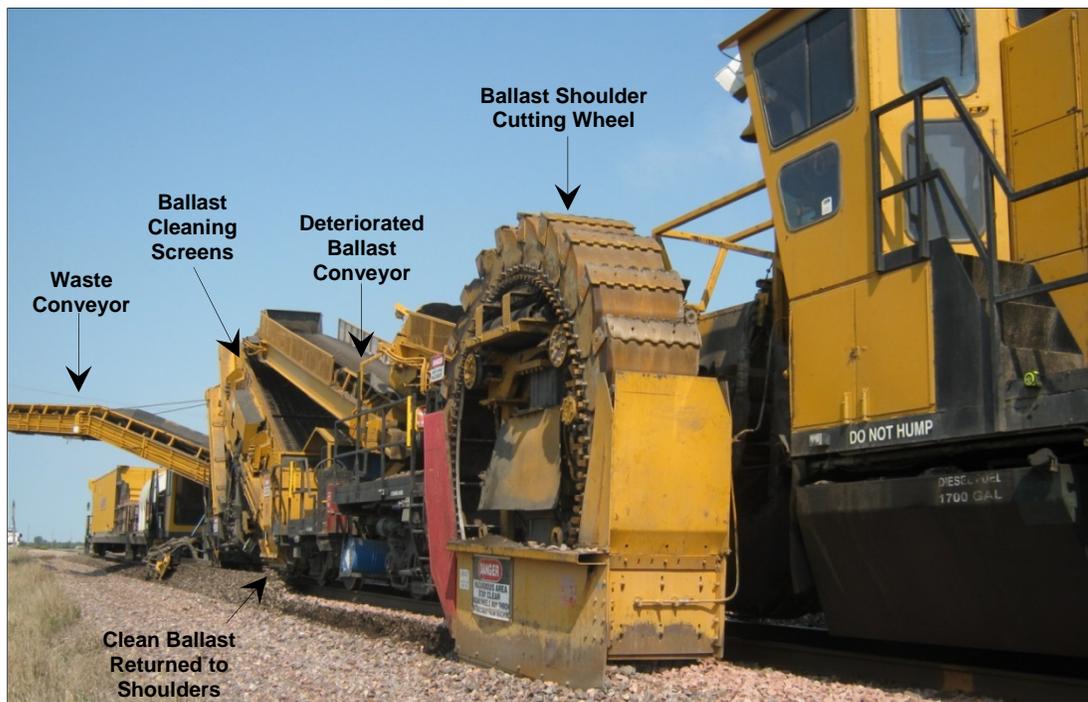
Figure 24. Details of Loram Ballast Shoulder Cleaning Operation

Note: Machine is symmetrical and cleans shoulders on both sides of the track simultaneously

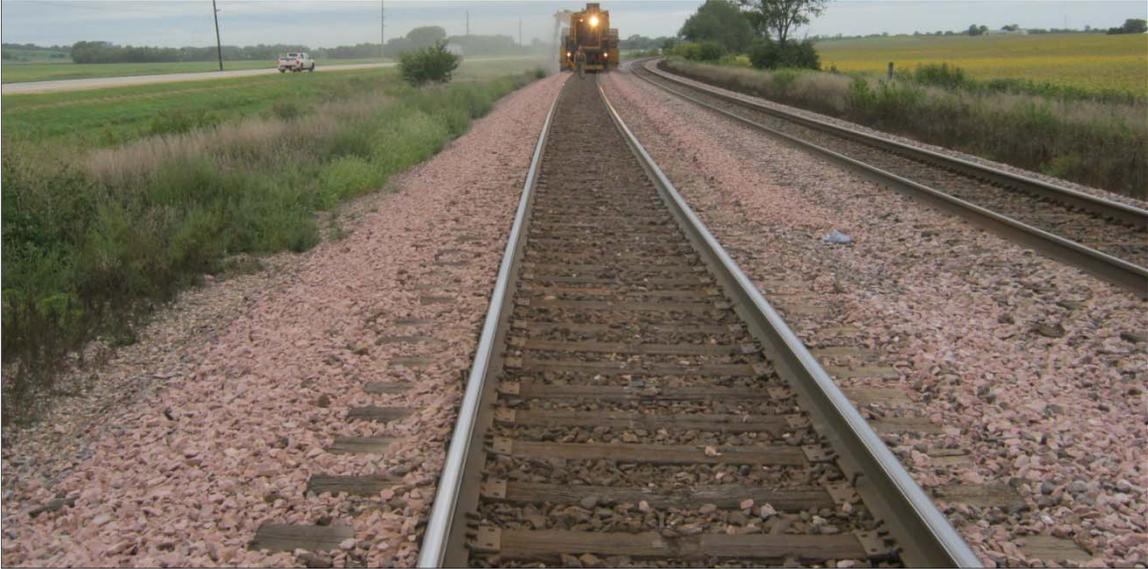
Figure 25. Test Site before Ballast Shoulder Cleaning
Note. New ballast (pink colored) along both ballast shoulders

A small amount of makeup ballast had been previously distributed along the ballast shoulder through the test site, in advance of the shoulder cleaning operations. This new makeup ballast was not included in the pre-test sample analysis, because samples were collected at levels below the ties, as Figures 18, 19, and 25 show.

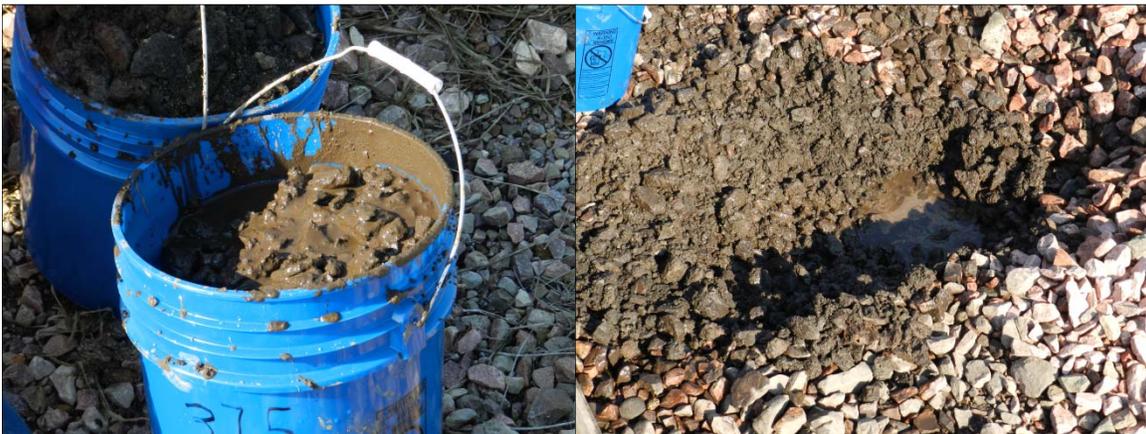
Figure 29. Example of Ballast Conditions before Ballast Shoulder Cleaning

This first set of samples was collected prior to the ballast shoulder cleaning operations, on Monday, August 27, 2012. The test site received 1.7 inches of rain on the day before; the samples collected were heavily deteriorated and very wet as Figure 29 shows.

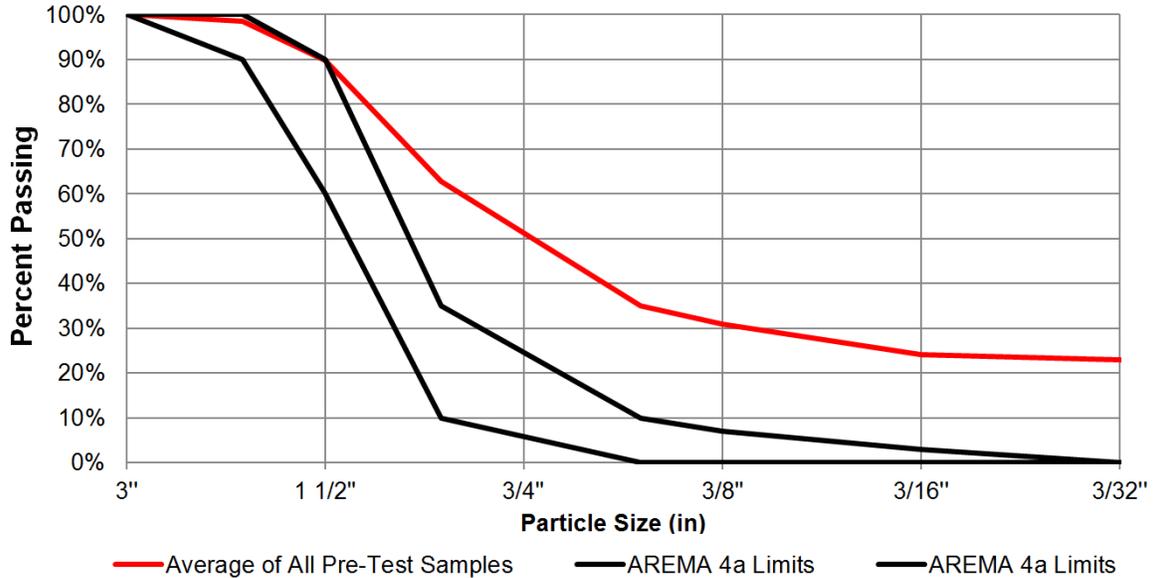
Figure 30. Pre-Shoulder Cleaning Samples Sieve Analysis Results

Figure 30 shows the average of the results of the ballast sieve testing for the 20 pre-shoulder cleaning samples using a semi-logarithmic scatter chart. The black lines indicate the upper and lower limits of new AREMA No. 4a ballast for comparison. Note the large percentage of ballast particle sizes less than 1½ inch in the pre-cleaning samples, indicating deteriorated ballast.

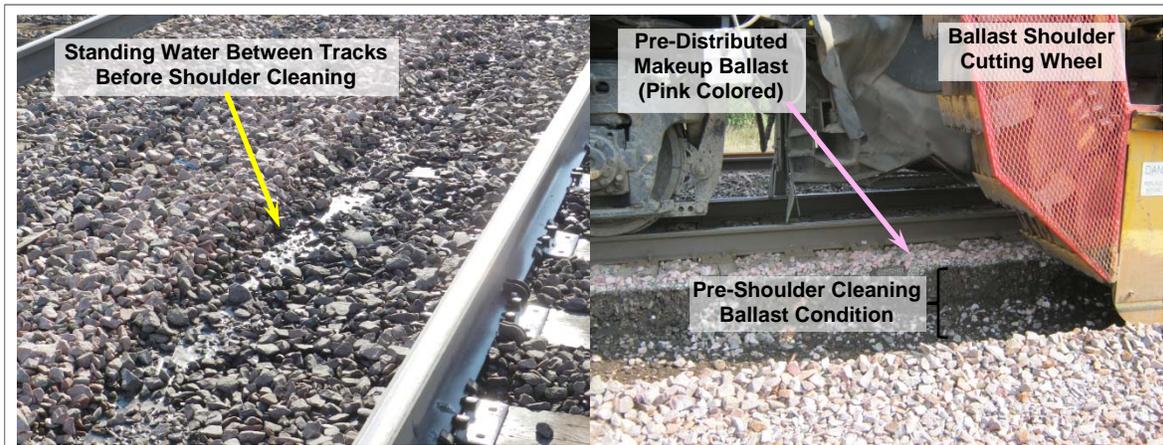
Figure 31. Pre-Ballast Shoulder Cleaning Ballast Conditions

All of these indices highlight the large amount of fines mixed in with the ballast prior to shoulder cleaning operations that were reducing the overall performance of the track structure. Figure 31 illustrates the condition of the ballast prior to shoulder cleaning.

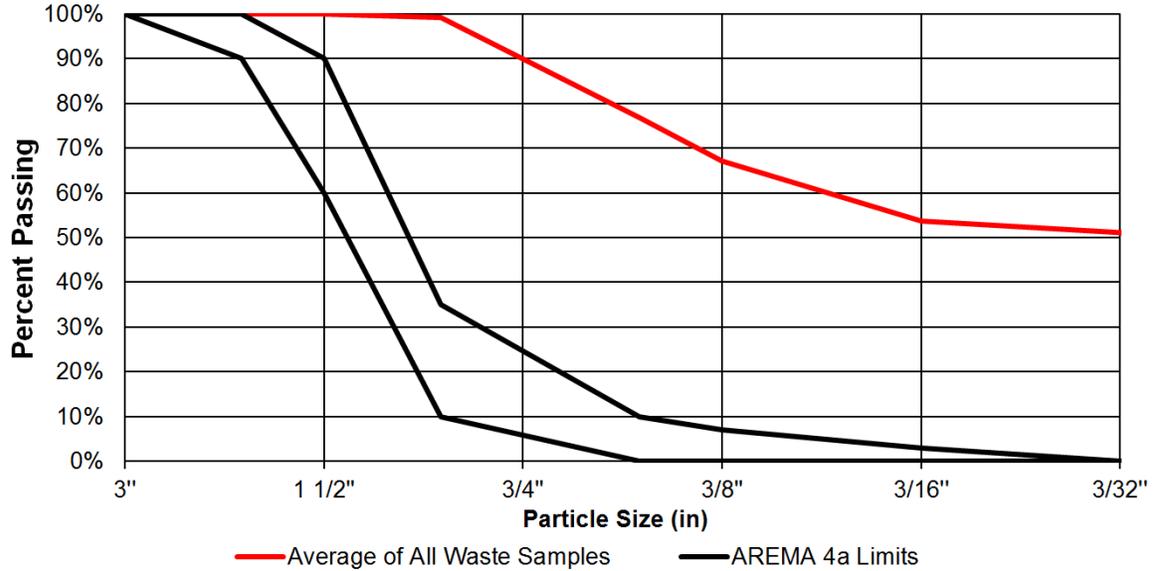
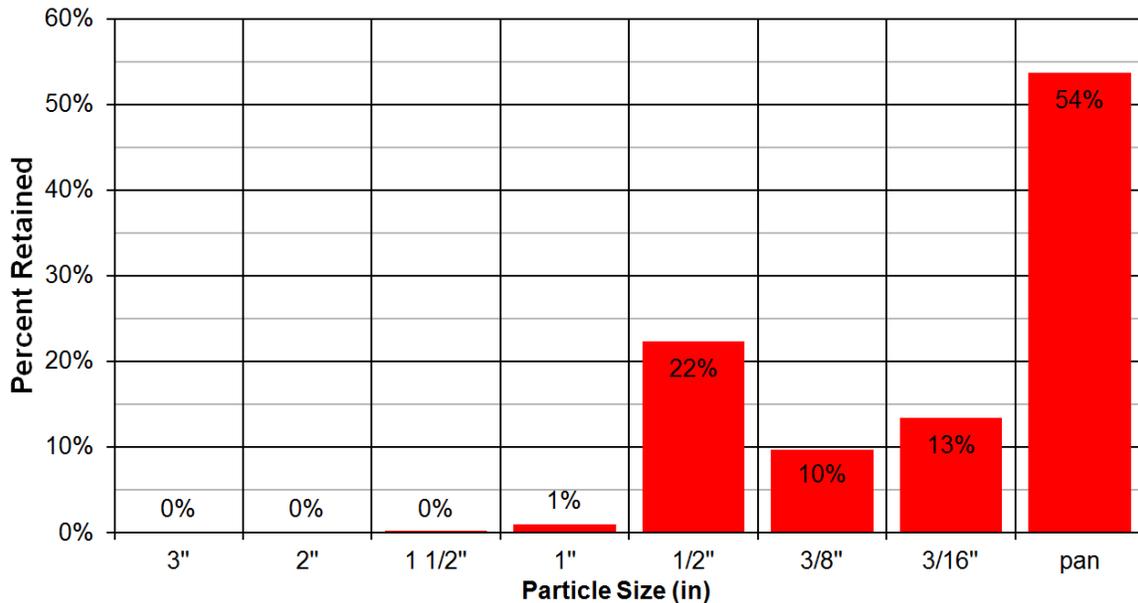
Figure 32. Ballast Shoulder Cleaning Waste Sieve Analysis Results

Samples of the waste fines removed by the ballast shoulder cleaning were collected and tested once, immediately after ballast cleaning operations. Figures 32 and 33 show the average results of the sieve analysis of all of the waste samples collected. Figure 33 shows that 99 percent of the waste material removed during the ballast shoulder cleaning process was ½ inch or less.

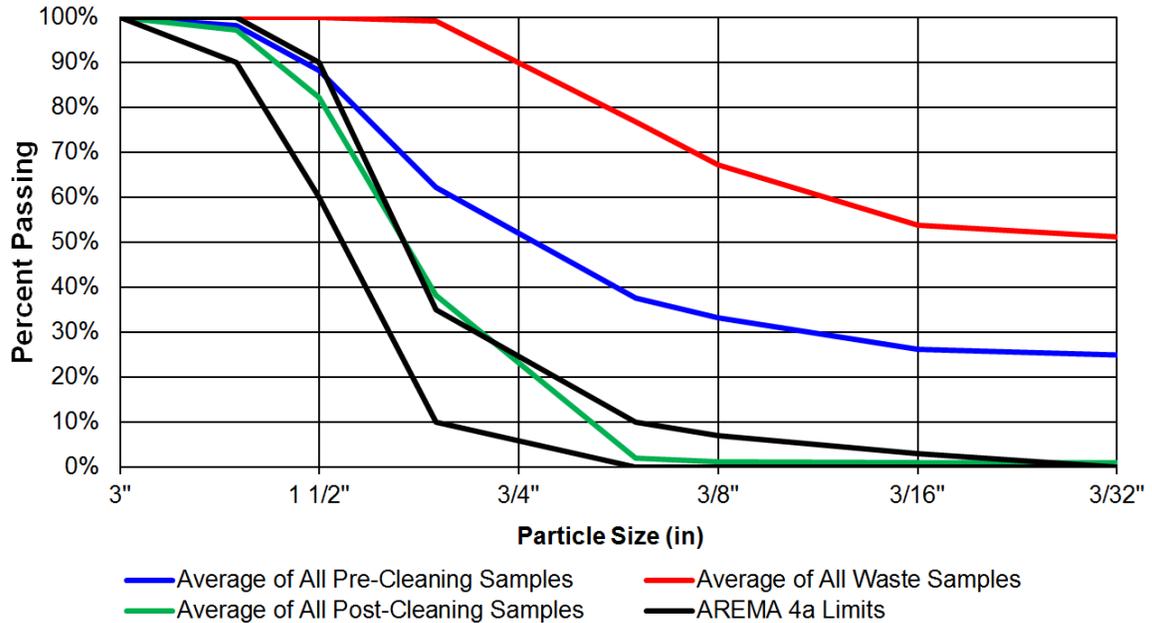
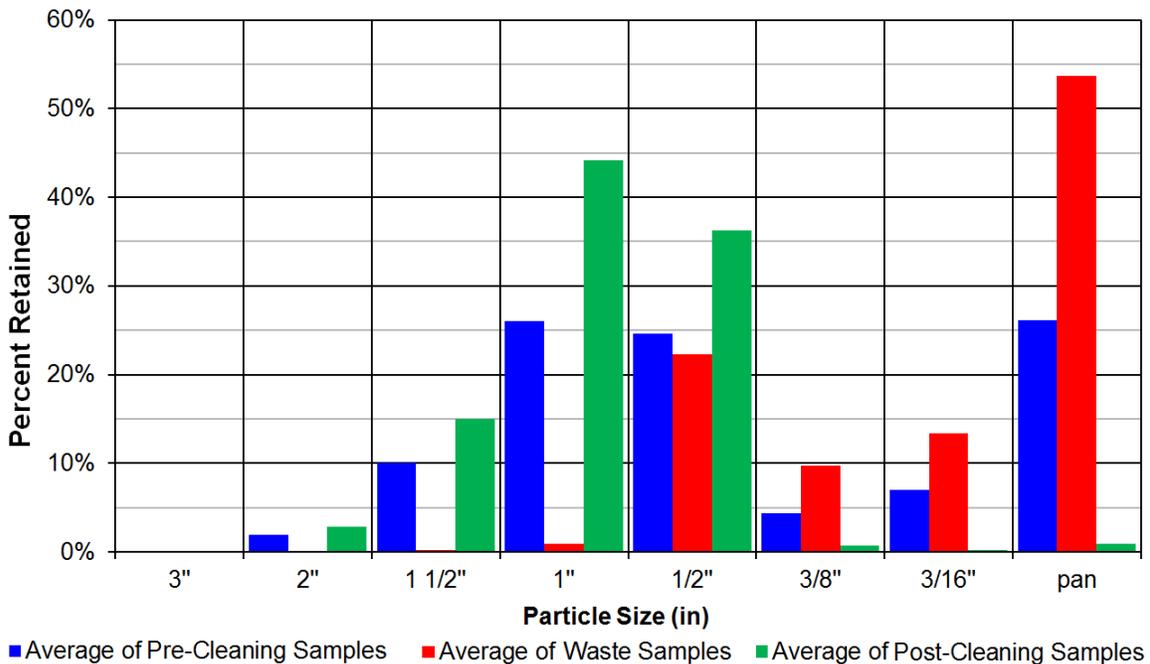
Figure 34. Results of Sieve Analysis Before and After Ballast Shoulder Cleaning

Figures 34 and 35 show the results of the sieve analysis for samples once immediately before and after ballast cleaning. The data from sieve analysis of the waste materials (Figures 32 and 33) is also included for comparison. Figures 34 and 35 show how the ballast shoulders were nearly restored to the condition of AREMA No. 4a ballast, eliminating nearly all of the fine materials. The only variance was near the 1-inch sieve size. All of the fine materials were well below the maximum allowable amount.

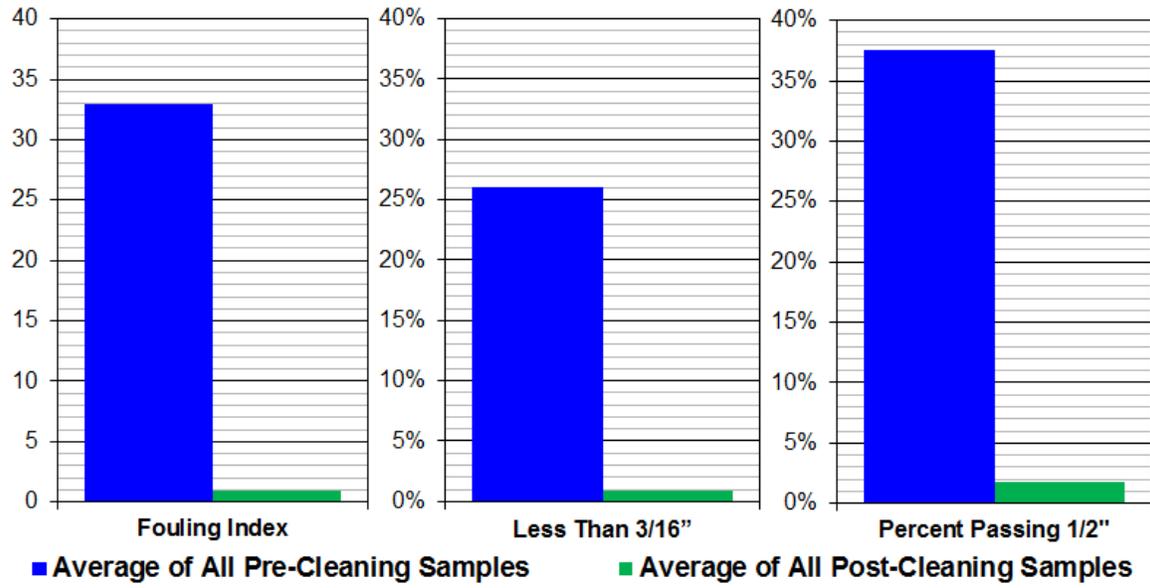
Figure 36. Comparison of Before and After Indices

As Figure 36 shows, the fouling index was reduced from 33 (fouled) to 1 (clean). The average of the fine material, less than 3/16 inch in the first post-cleaning sample was 1 percent, and the average percent passing a 1/2-inch sieve size was reduced to 2 percent. All of this data indicates that the ballast shoulder cleaning process was highly effective in removing fines and restoring the shoulder ballast to the sieve sizes recommended for AREMA No. 4a ballast.

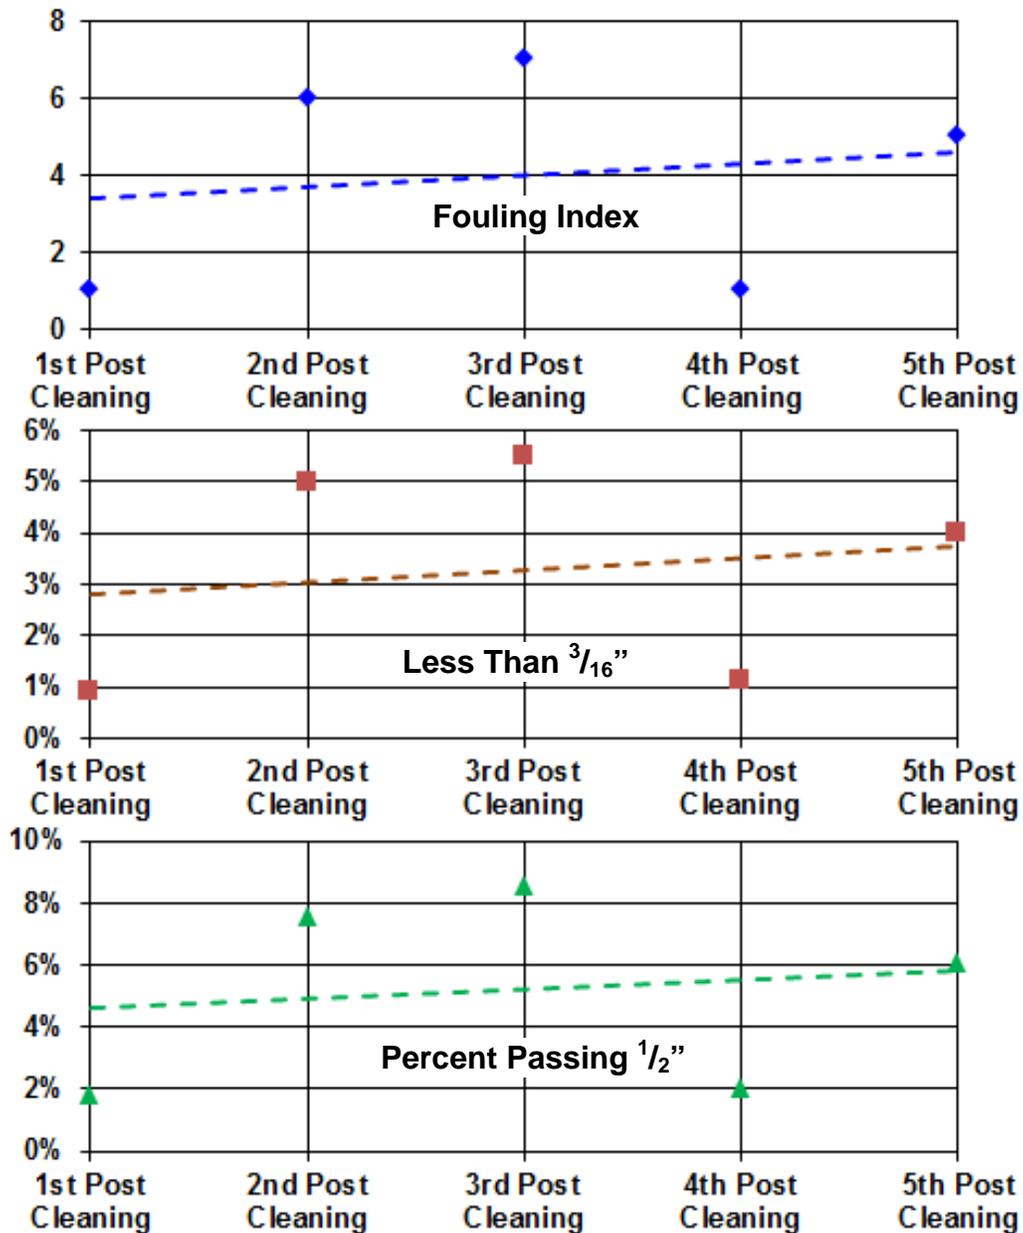
Figure 49. Combined Sieve Analysis Results for All Shoulder Samples

Figure 49 shows the details of the sieve analysis results for all of the ballast shoulder samples through the life of the test. The Fouling Index, Percent Retained in Pan (Less Than 3/16 inch) and Percent Passing 1/2 inch are all trending up.

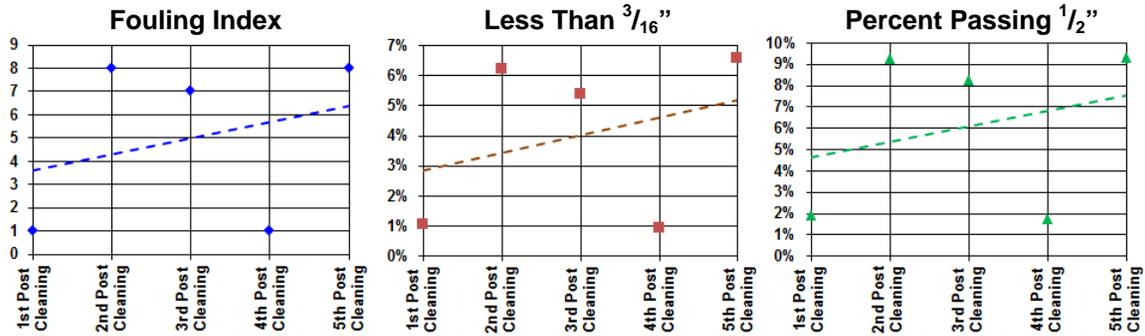
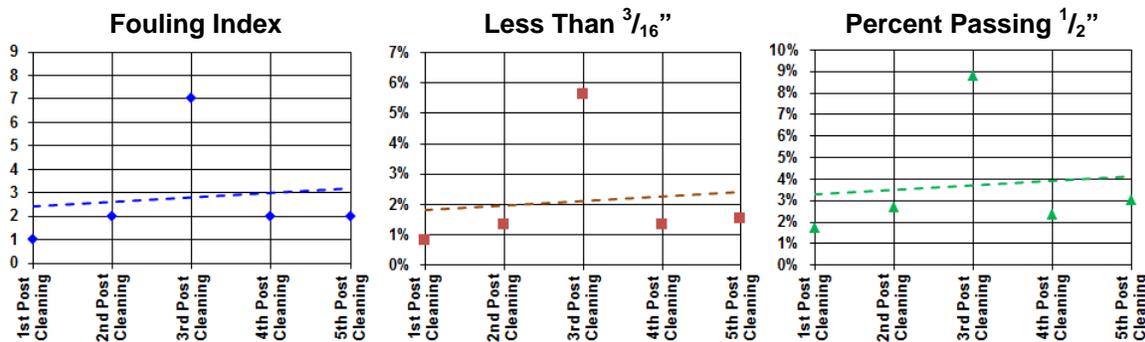
Figure 50. Combined Sieve Analysis Results North Shoulders (Between Tracks)

Figures 50 and 51 detail the combined sieve analysis results for all of the ballast shoulder samples through the life of the test. The north shoulders, located between the tracks (Figure 50) show a much higher rate of increase of fines, nearly double, than the south shoulders, located along the outside of the trackway (Figure 51). This suggests that the shoulders cleaned between the two tracks are draining both tracks, not just the track where ballast cleaning was performed.
