**BALLAST SHOULDER
CLEANING EVALUATION**

P-15-006

for Loram Maintenance of Way, Inc.

**Transportation Technology Center, Inc.
A subsidiary of the Association of American Railroads
Pueblo, Colorado USA
February 25, 2015**

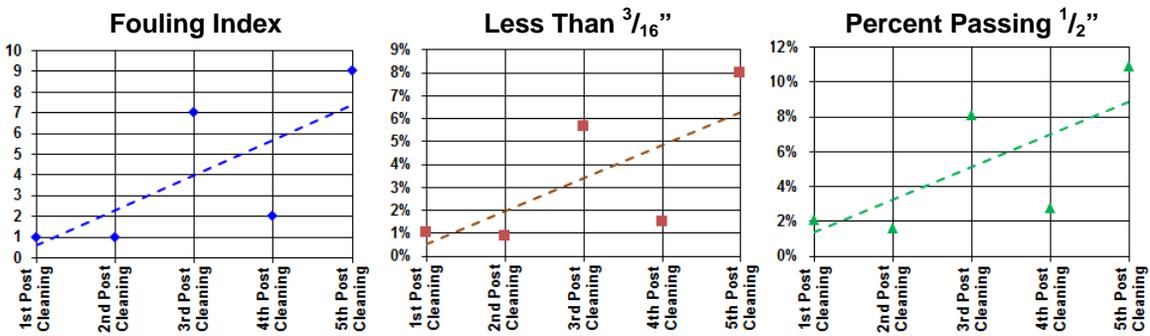
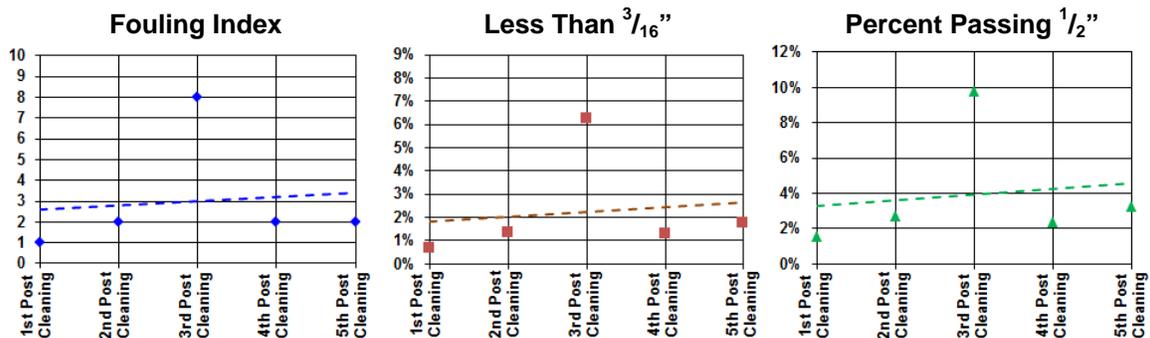
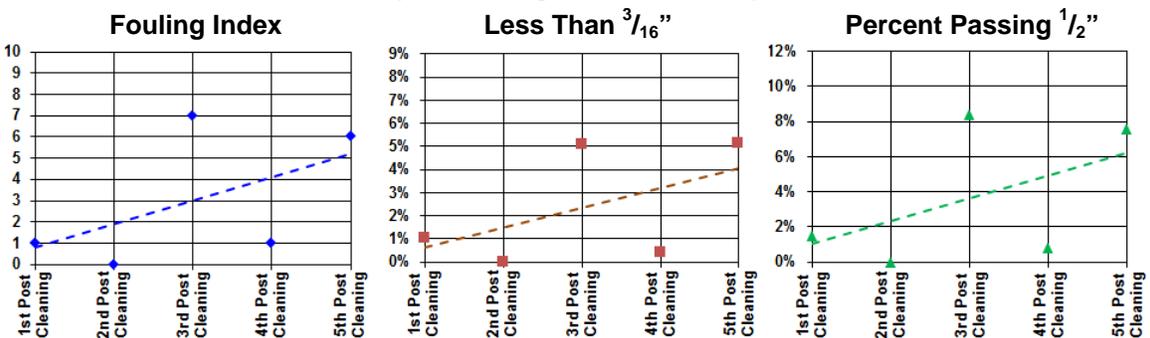
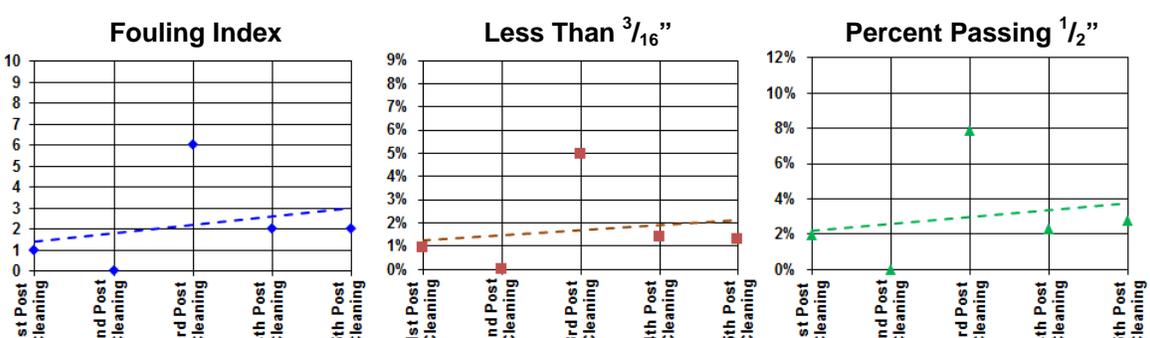
Figure 52. Combined Sieve Analysis Results Curved Track North Shoulder (Low Side Shoulder Between Tracks)

Both curved and tangent tracks show similar trends as all of the results combined, with the shoulders between the two tracks showing approximately double the amount of fines as the outside shoulders. The results of the north shoulders on the curved track are slightly higher than the north shoulders on tangent track. This suggests that fines may have a higher propensity to migrate towards the low side of superelevated curves.
