## VACUUM EXCAVATION TECHNOLOGY FOR BALLAST AND GRADE REMEDICATION ON SPECIAL TRACK WORKS

### SUMMARY

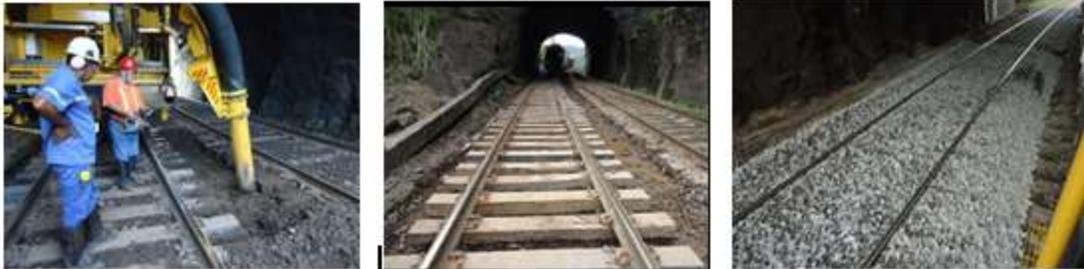
The Railvac can take your Specialty Trackworks from:

This

To This

in less time, with fewer resources and less disruptions than traditional methods for your Specialty Trackworks Ballast Remediation Projects.

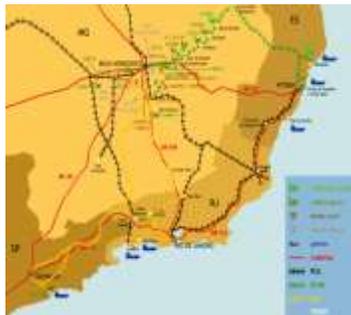
MRS Logistica S.A. (MRS) is a Brazil-based company engaged in transportation services. The company focuses on freight railroad transportation and is active in the control, operation and monitoring of the Southeastern Broad Gauge Network (Figure 1) since December 1996. The company has been in railway transportation of cargo including iron ore, finished steel products, cement, bauxite, coal, containers and agricultural commodities, among others. It interconnects the Brazilian states of Minas Gerais, Rio de Janeiro and Sao Paulo, as well as ports of Rio de Janeiro, Guaiaba, Itaguaí and Santos. This region amasses approximately 55% of Brazil’s gross domestic product and is home to the country’s largest industries.

**Figure 1: MRS Logistica Southeastern Broad Gauge Network**

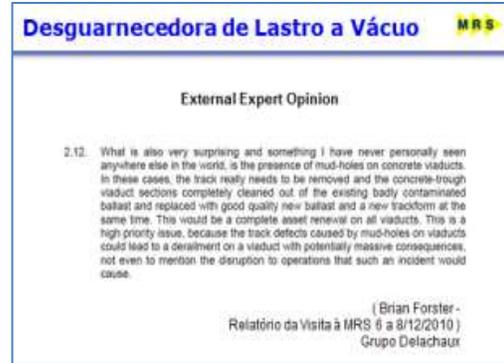
**Figure 5: Section 2.12 of the Delachaux Group Report**

Realizing the current method of ballast and drainage maintenance on Specialty Trackwork assets was insufficient, MRS went on a mission to find a better and more productive method. MRS hired Delachaux Group as a consultant. Following a study of the MRS System, Delachaux Group provided a report of their findings. A part of the Delachaux Group's report relating to the concrete viaducts recommended the complete removal of the existing badly contaminated ballast and replaced with good quality new ballast and a new track (ties and rail) at the same time (Figure 5).

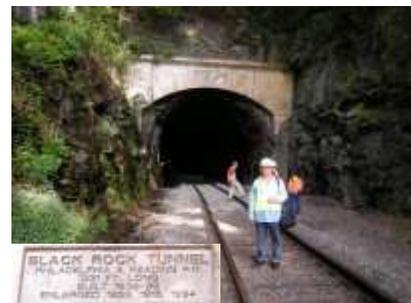
**Figure 6: Visit to North America Class 1 Railroad**

An MRS exploratory team visited a North America Class 1 railroad to discover how they were cleaning their tunnels (Figure 6). On their visit, they witnessed a Loram Railvac™ undercutting fouled track in a tunnel with tight restrictive clearances, which mirrored the conditions on MRS's system. The track had serious drainage issues and the ballast was very wet and contaminated. The MRS Exploratory Team realized that with a Railvac they could be more productive in maintaining the ballast in their tunnels and on their bridges and viaducts. With the Loram Railvac the opportunity to maintain their Specialty Trackwork assets to a higher standard was possible. The team's next step was the development of a justification for the investment in equipment and training for the next generation of Specialty Trackwork Rehabilitation Methodology.

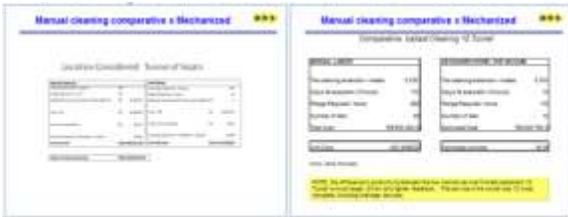
Figure 11: Tunnel -Comparison used in Justification[SAB4]

dependent on the complexity of the ballast replacement work being completed. The average unit cost under the traditional method is R\$290.29 (\$91.73 USD) (Figure 11). Comparing the average unit cost under the traditional method against the estimated unit cost of the Railvac results in a per unit savings of R\$196.34/m<sup>3</sup> (\$62.04 USD/m<sup>3</sup>). With an annual production estimate of 12480 meters (40945 feet) the estimated annual savings would be R\$2,450,260 (\$774,228 USD).

MRS estimated the unit cost of the Railvac at R\$93.95 (\$29.69 USD). This included the depreciation cost of the Railvac, operating expenses and wages of 12 people. Under MRS' traditional method the unit cost ranged from R\$155.13 (\$49.02 USD) on the low end up to R\$425.44 (\$134.43 USD). This range was

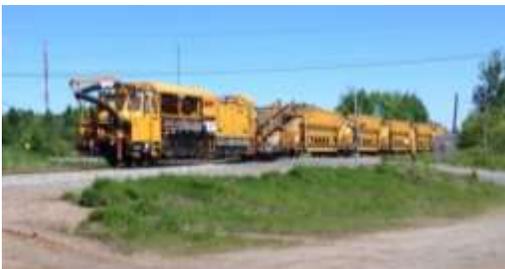
**Figure [SAB6]13: Railvac Consist used on Bathurst Project**

The remedial work was performed in the summer of 2014 using a Loram Railvac, equipped with HEPA filters and five Knapp cars supplied by CN. A total of 4,100 tonnes (4,500 tons) of recovered ore-impacted ballast was 1) excavated from the track by Loram's Railvac, 2) transferred to the five Knapp cars and 3) transported to the Mine site by the Loram's Railvac for re-use, which resulted in greenhouse gas reduction of >300 tonnes of CO<sub>2</sub> equivalent (Figure 13). During the remediation process air quality protection measures were utilized to mitigate dust and real-time particulate matter monitoring was completed.

Utilizing the specialized rail bound equipment, the remedial work was completed successfully. There was no disruption to rail service and no complaints from the public. It also resulted in significant cost savings to CN because the project generated less waste material than conventional remedial techniques and was completed in four weeks versus the projected eight weeks.
