AUTOMATED CROSSTIE INSPECTION USING INTERNAL IMAGING TECHNIQUES

ABSTRACT

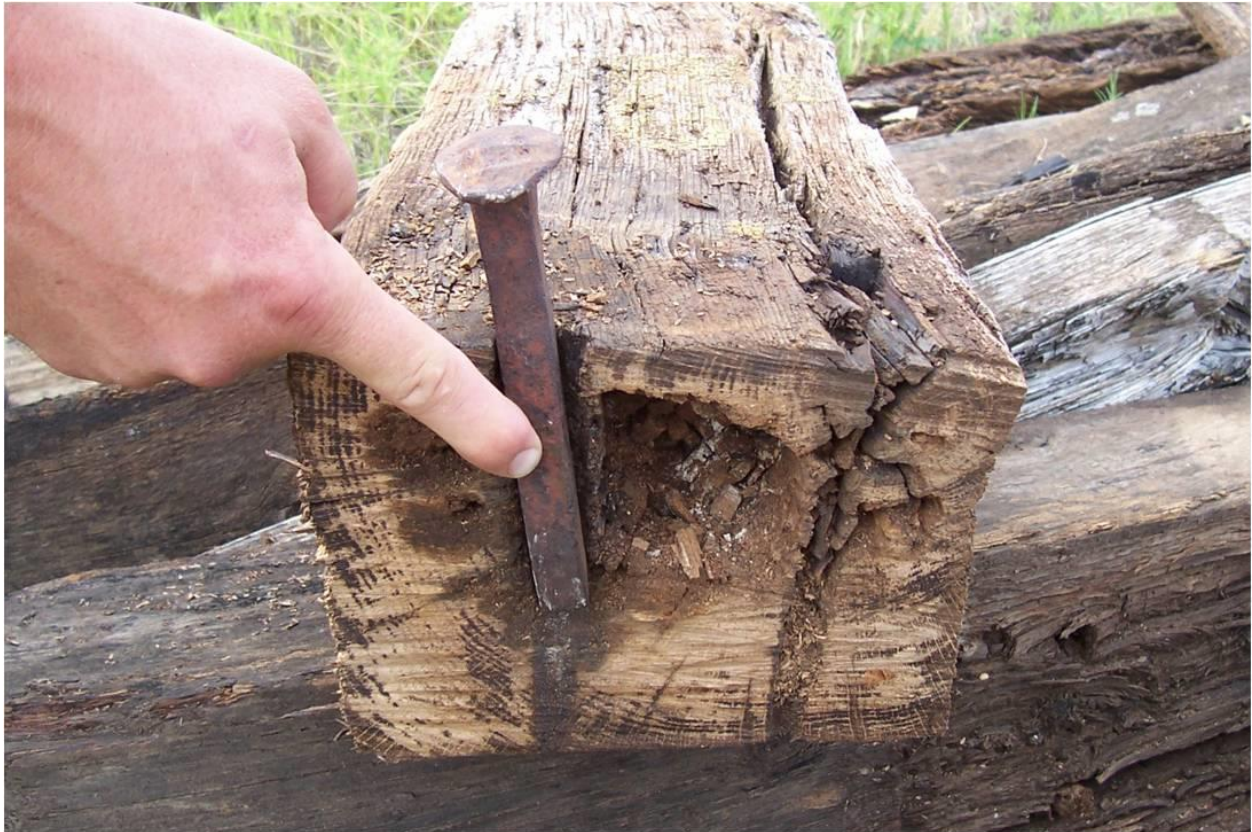
Figure 2: A Subsurface Defect is shown in proximity to a spike hole

Traditional grading techniques involve human tie inspectors visually grading the tie surface and kicking the tie to determine if it is hollow or not. The reliability of this technique for grading purposes is questionable. Results can vary based on which part of the tie was struck, surface accessibility, and type of tie material (wood species, etc.). See **Error! Reference source not found.** for an example of a tie with a localized subsurface flaw.

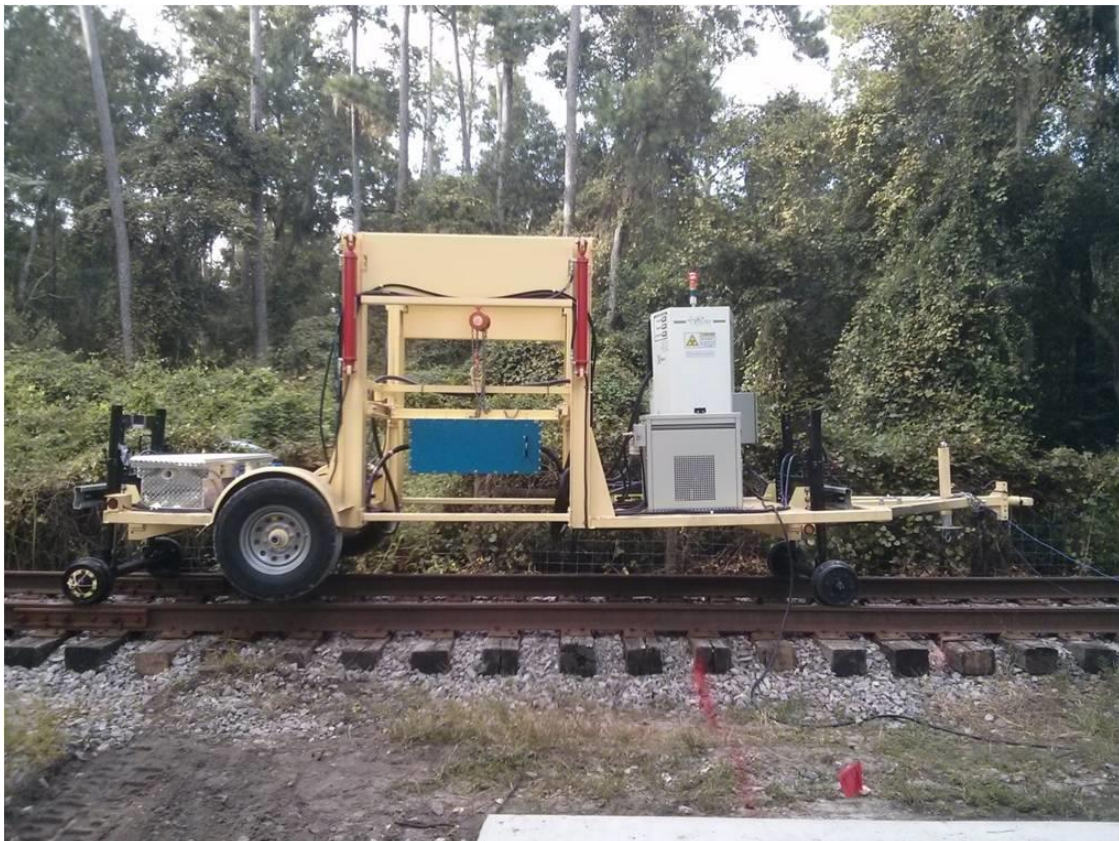
Figure 5: Research cart on the wood tie research track. The blue box in the center of the cart houses the Source.

Additionally, a hi-rail research cart (see **Error! Reference source not found.**) was designed and fabricated to provide the ability to test and verify various configurations of

the X-ray components, and relevant system and safety design. Features of the research cart include:

- The ability to position the Source at heights ranging between 24" and 84" above the surface of the tie.
- The ability to move the Source laterally 30" from the centerline of the track in either direction.
- The ability to rotate the Source laterally 30° from perpendicular to the track surface in either direction.
- The ability to tow behind an Aurora truck without interfering with Aurora's image acquisition. This allows system integration research without having to build an Aurora system on the research cart.

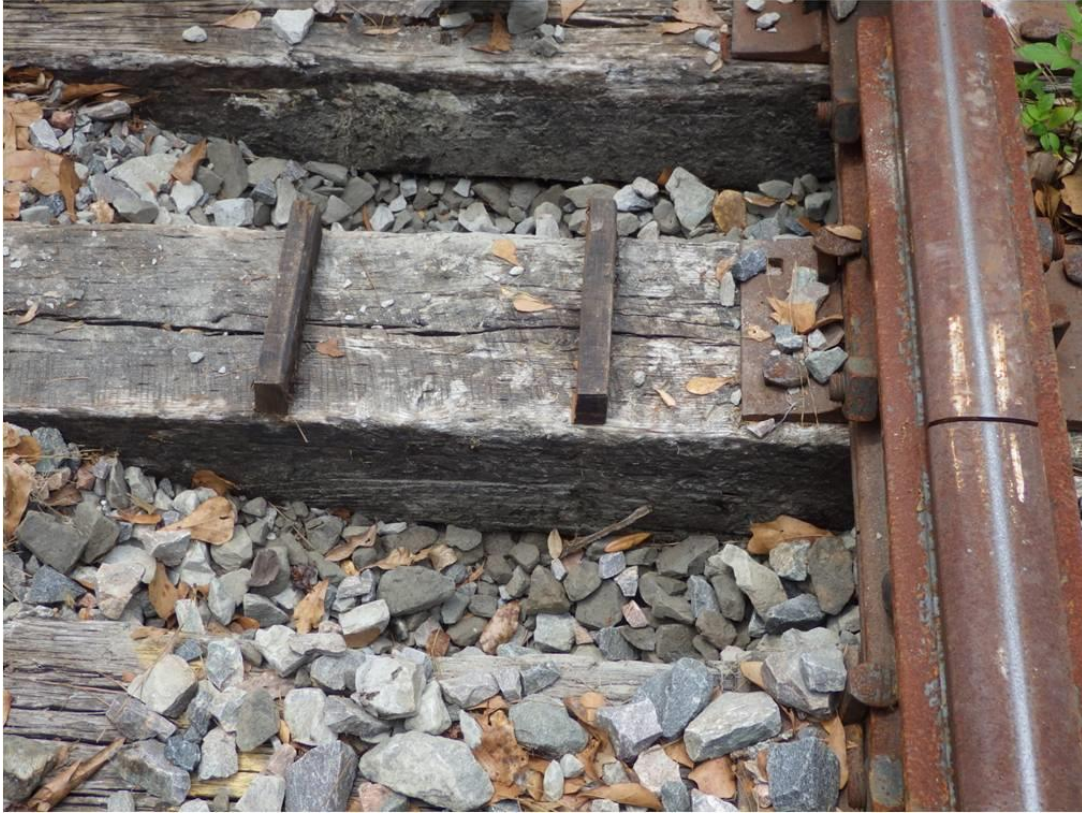
Figure 8: Tie surface before destructive examination. The void in the X-Ray image is between the two cross-member pieces of wood.

Of particular interest was the leftmost tie in **Error! Reference source not found.** The density profile ranged from 700 – 900, and showed a larger degree of variation in values across the tie. Also a significant void is visible near the top part of the image. However, the surface of the tie is in good condition (see **Error! Reference source not found.**). The crib ballast around the tie was removed and the 3 visible faces of the tie examined which showed no sign of internal defects. The voided region indicated in the X-Ray image is marked by the 2 cross-directional pieces of wood. A destructive test was performed on this tie to verify the X-Ray results. The results are shown in **Error! Reference source not found.**

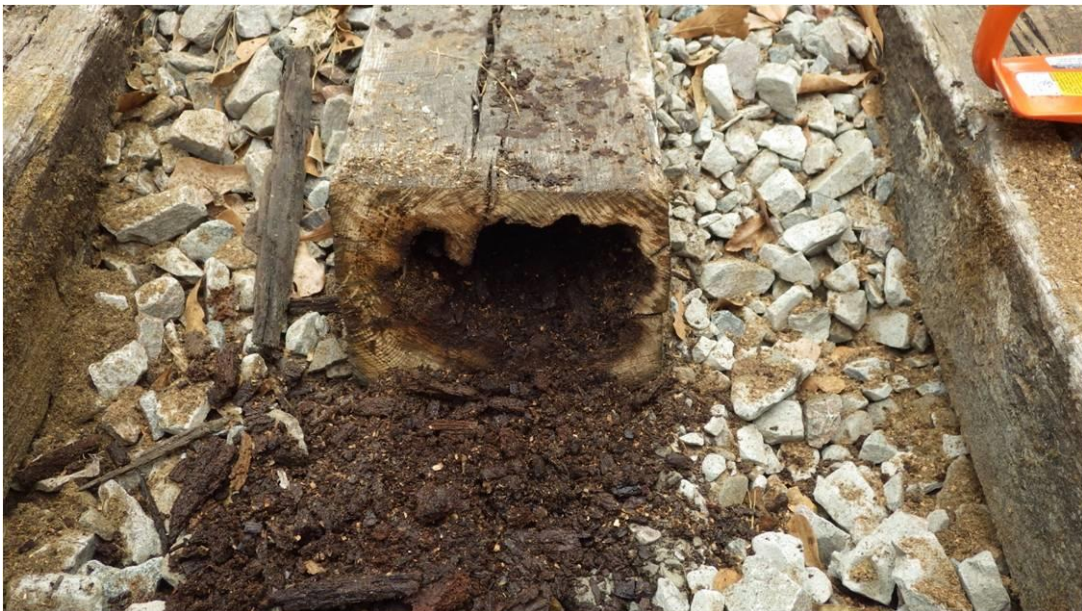
Figure 9: Tie surface and subsurface after destructive examination. The void is readily apparent.

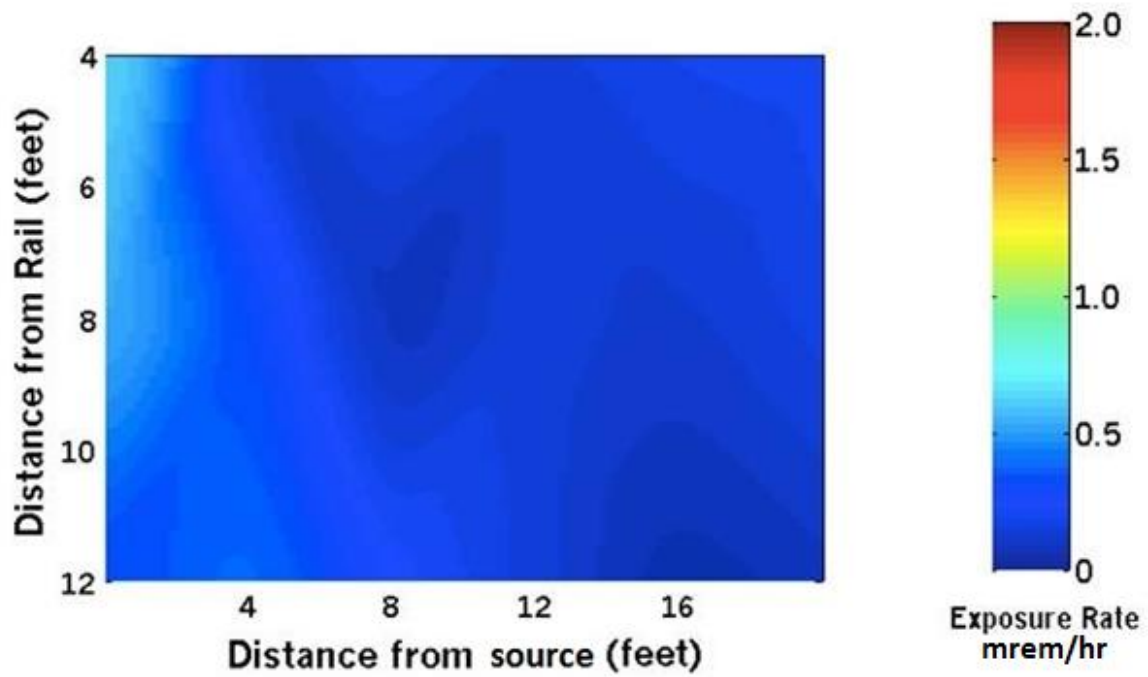
Figure 11: Plot of exposure rates 3 feet above the surface of the tie.

TABLE 1: Radiation Exposure Levels 3 Feet above Railroad Tie Level

Distance from source (feet)					
Distance From Rail (feet)		0	4	8	12	16	20
	4	0.61	0.17	0.21	0.15	0.19	0.21
	8	0.53	0.31	0.09	0.14	0.12	0.17
	12	0.31	0.38	0.24	0.14	0.05	0.08

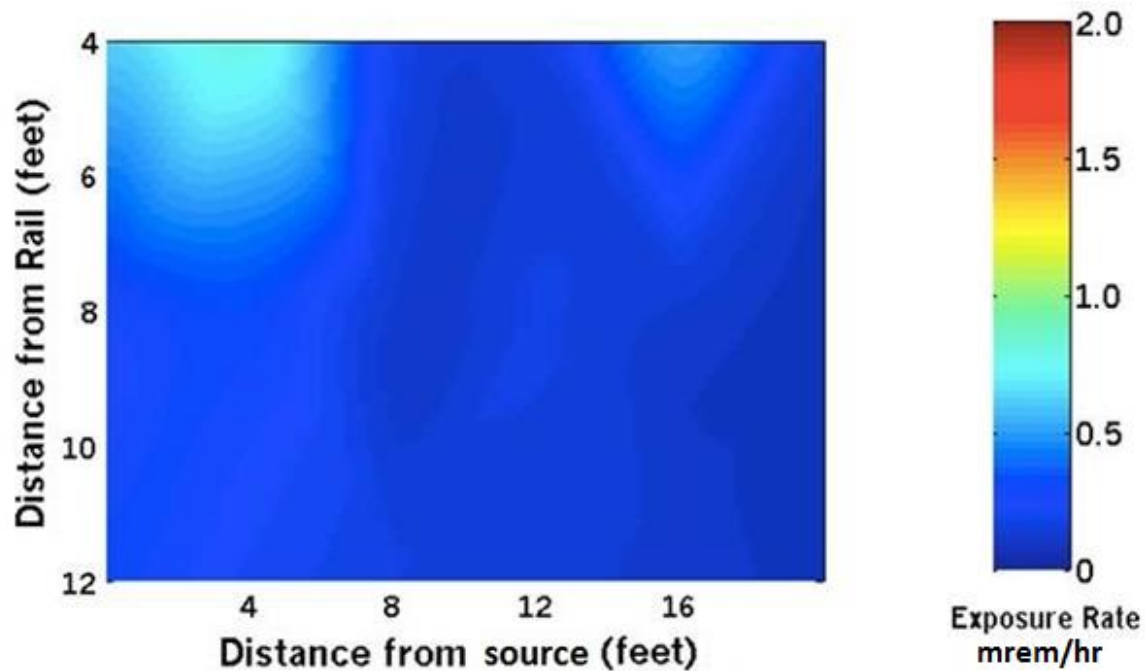
Figure 12: Plot of exposure rates 6 feet above the surface of the tie.

TABLE 2: Radiation Exposure Levels 6 Feet above Railroad Tie Level

Distance from source (feet)					
Distance From Rail (feet)		0	4	8	12	16	20
	4	0.63	0.80	0.20	0.16	0.51	0.16
	8	0.26	0.31	0.12	0.16	0.12	0.07
	12	0.29	0.21	0.16	0.14	0.11	0.08
